General Home Inspection

1234 Busy St
Fullerton, CA 92833

OC Home Inspect

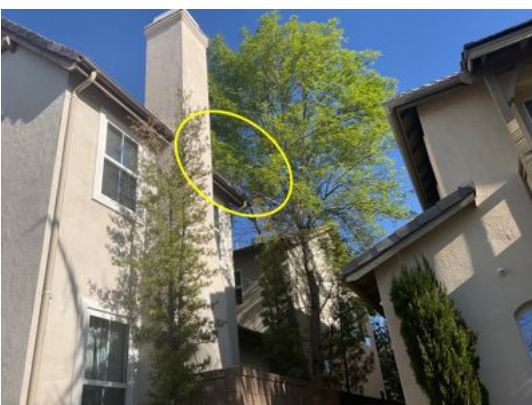
Tree growing over roof on right side of house.

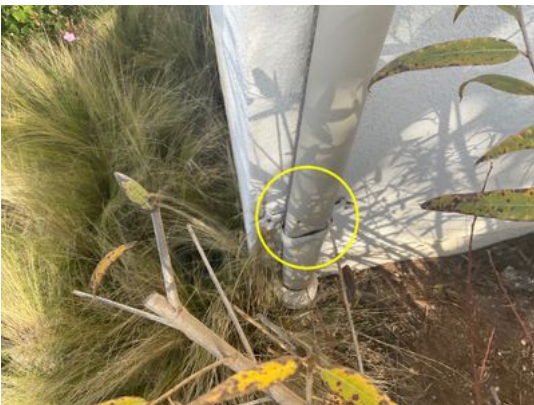
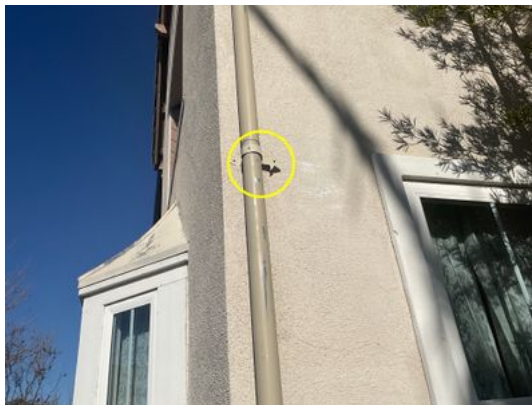
Downspout is crushed and strap is loose at front of house.

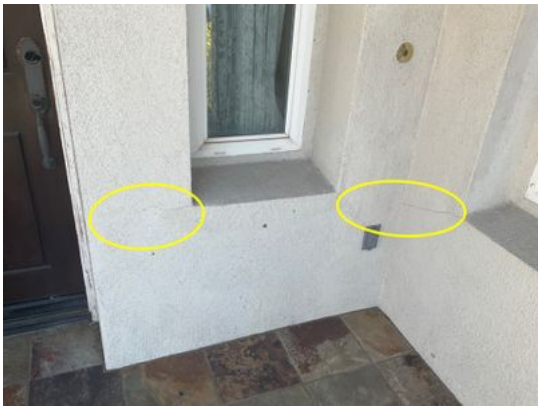
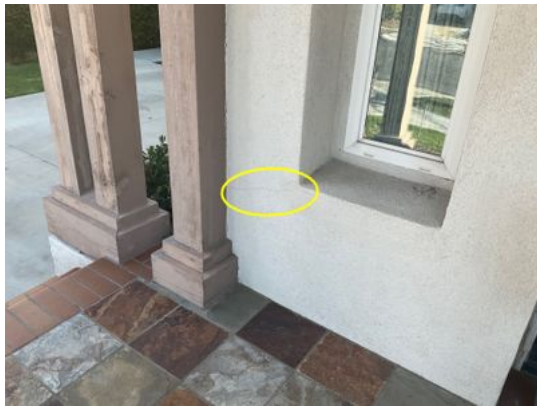
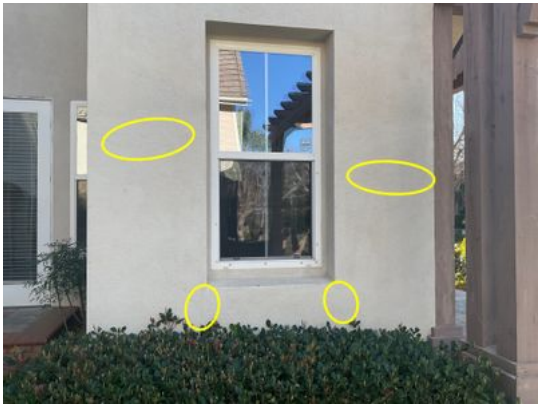
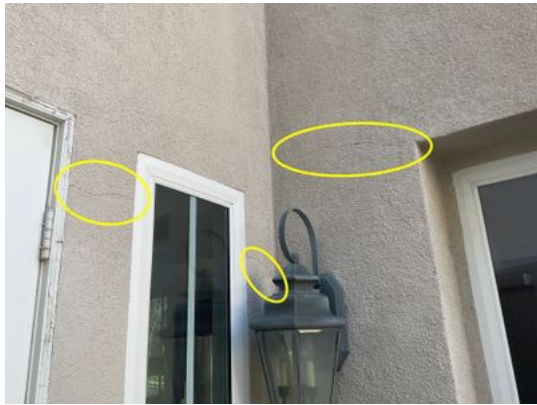
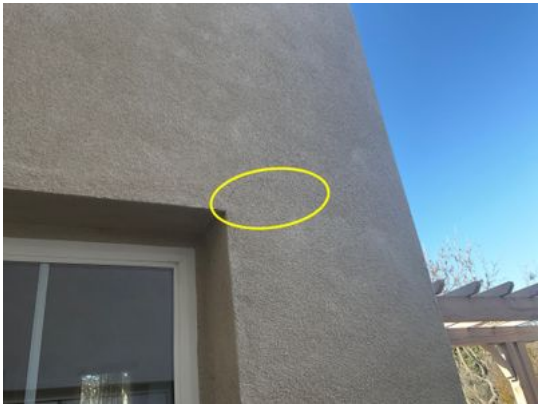
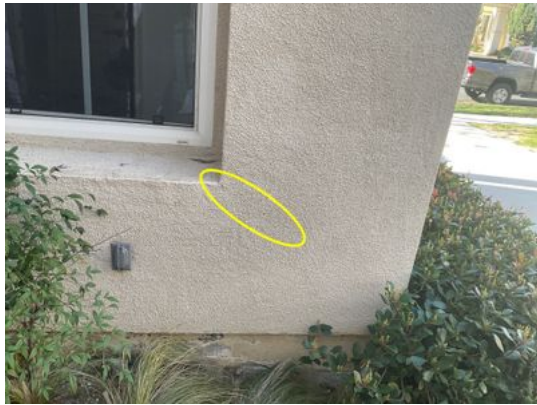
Stucco cracks on exterior walls.

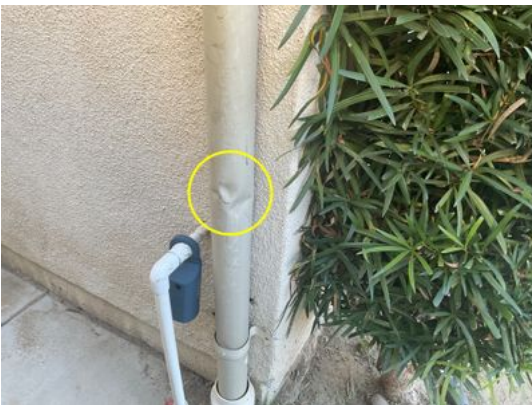
Downspout is dented front of house.

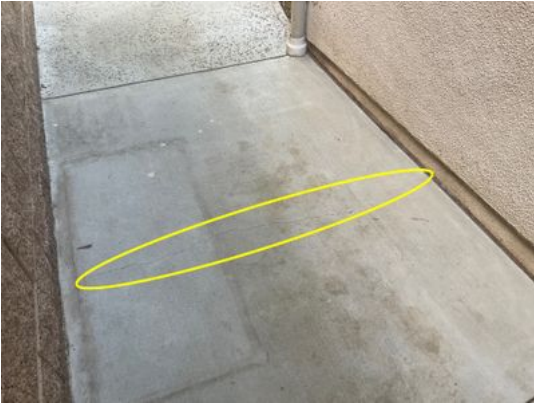
Concrete is cracked at walkway left side of house.

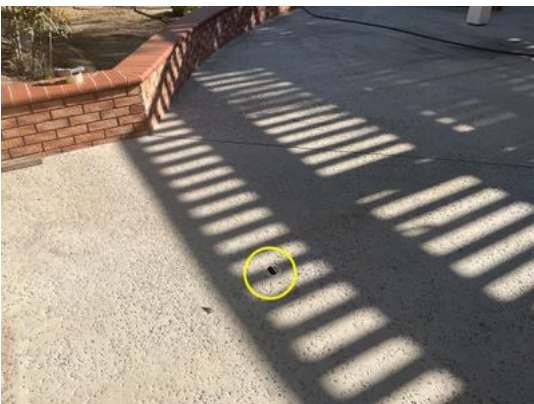
Drain grate/cover is damaged at patio back of house.

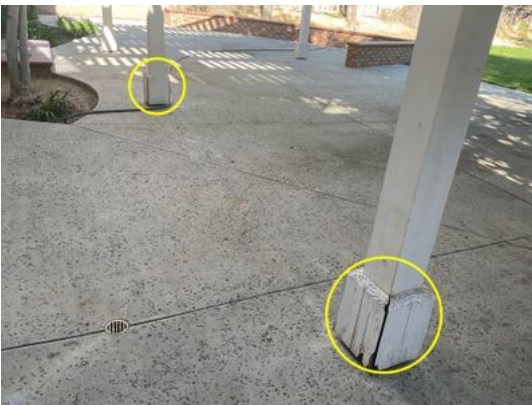
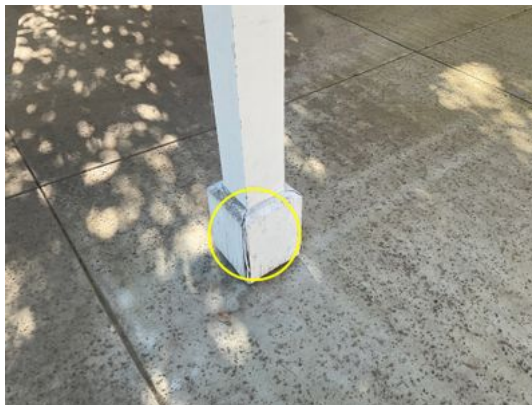
Water damage at bottom of pergola posts back of house.

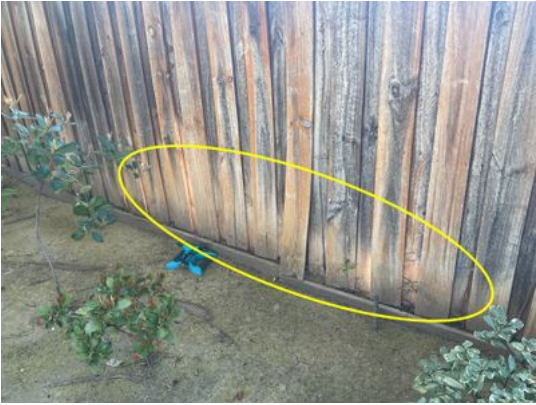
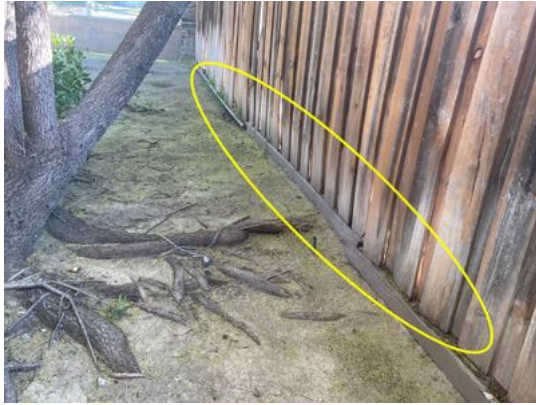
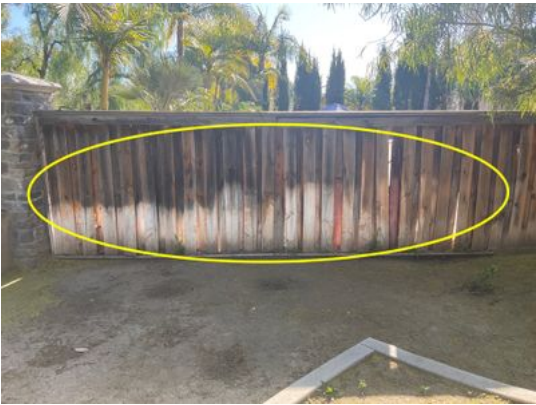
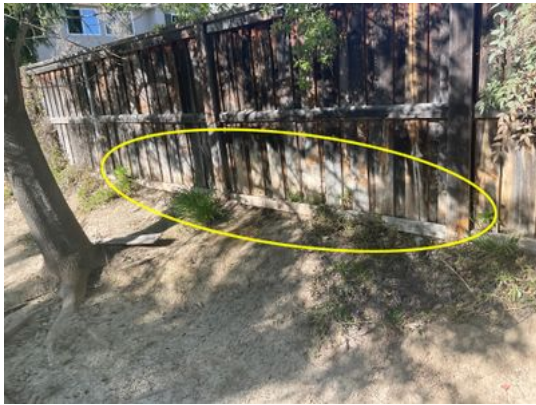
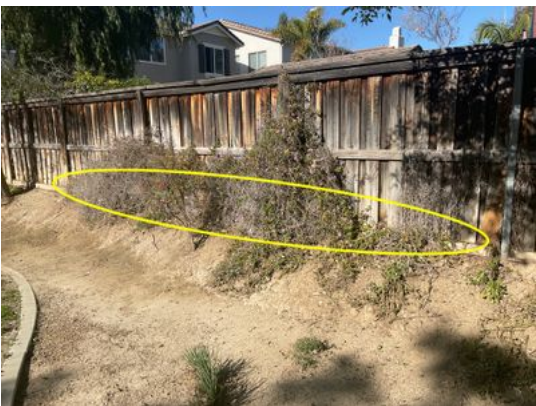
Water damage at fencing back of house. Fence installed against ground soil.

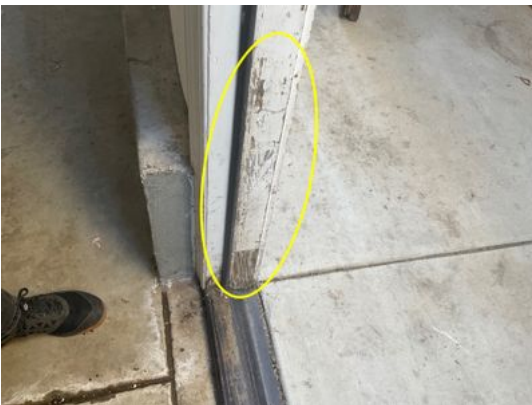
Paint has failed at all exterior door jambs.

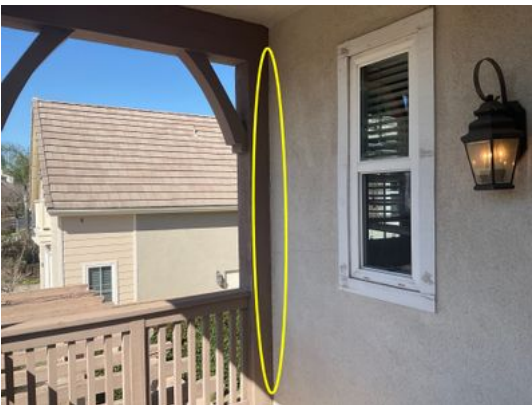
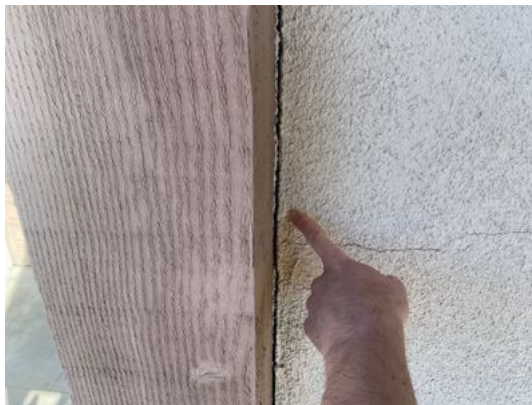
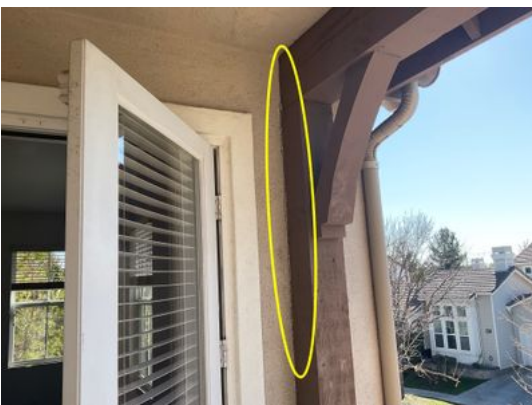
Posts have separated from wall, gap at stucco at balcony.

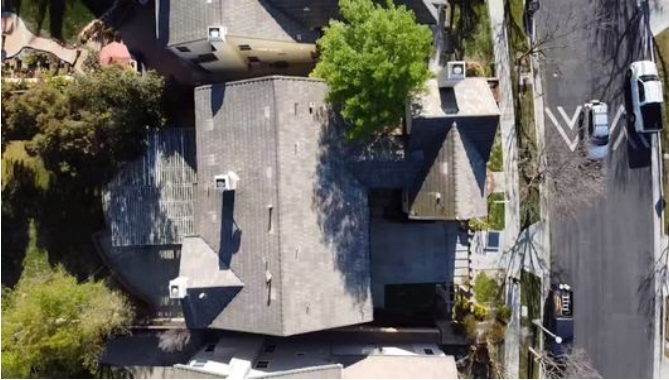
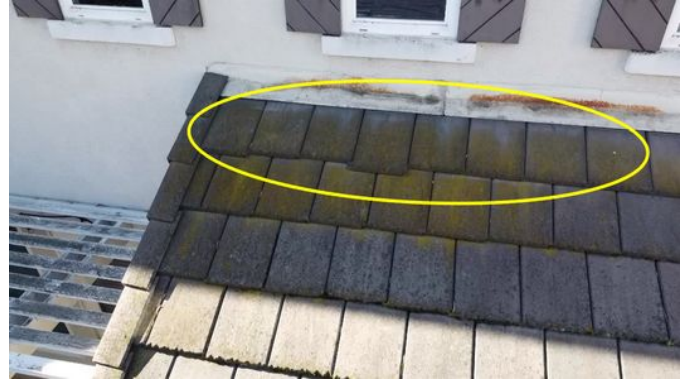
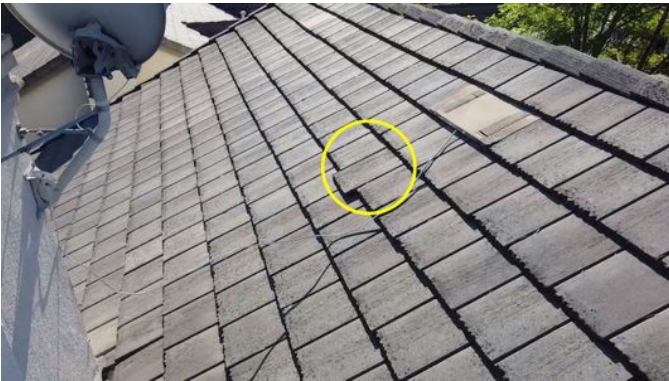
Loose tiles sliding out of place.

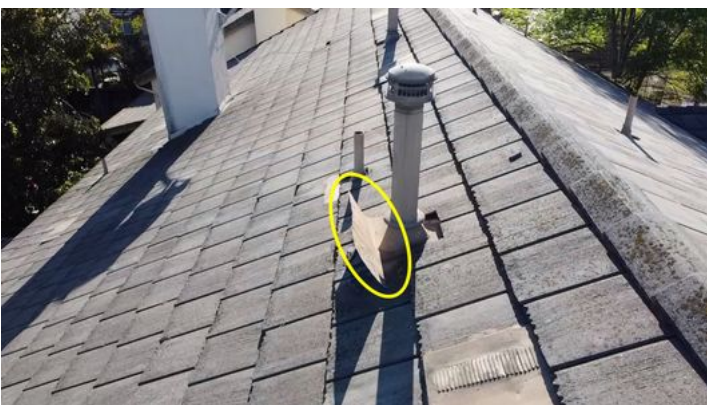
Flashing is bent.

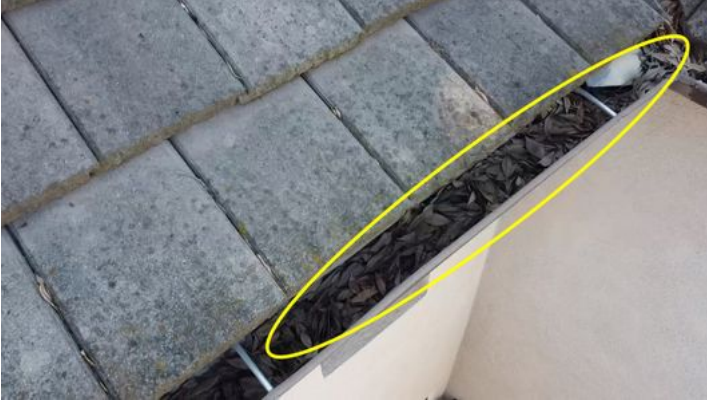
Gutters are full of leaves.

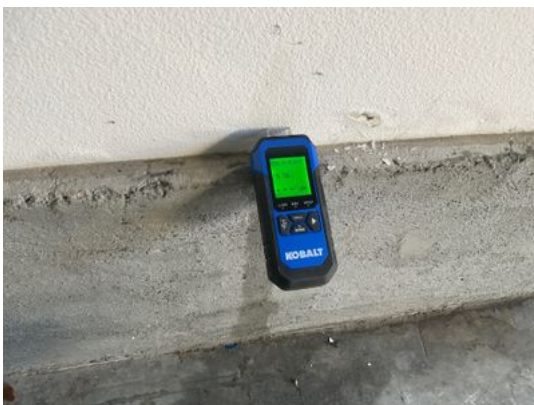
Water stain at wall and foundation right side of garage. Low levels of moisture detected with moisture meter. A skim coat has been applied to the foundation.

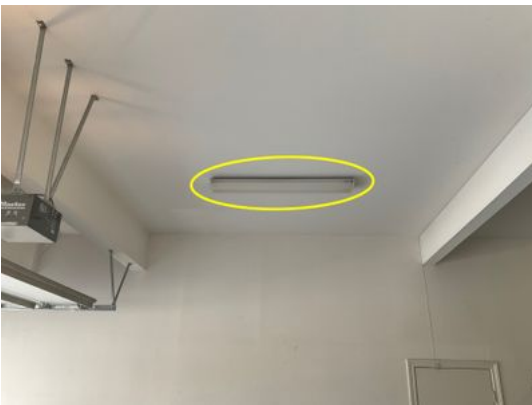
Light fixture does not turn on at ceiling.

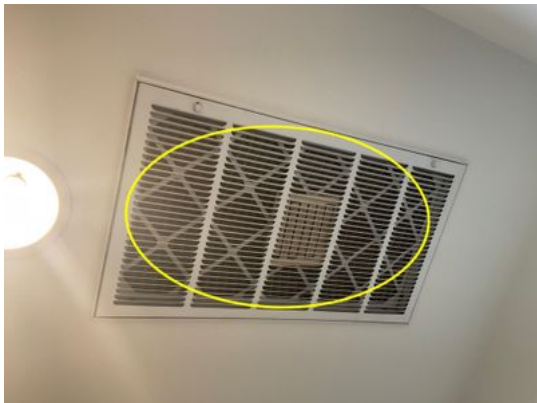
Return air filter is dirty.

Furnaces over 10 years old should be checked, cleaned and serviced yearly by a licensed contractor.

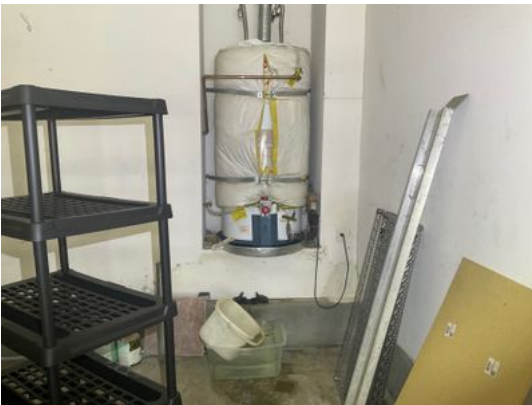
Water heater is leaking.

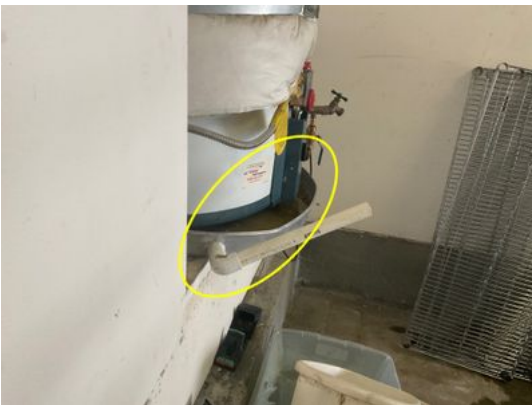
Water heater does not fit on platform. Appliance hangs over edge.

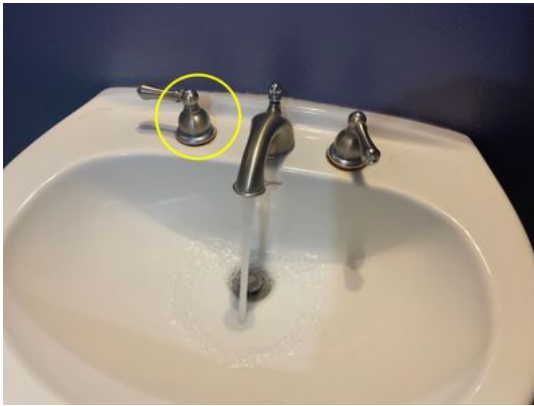
Hot valve is loose at sink.

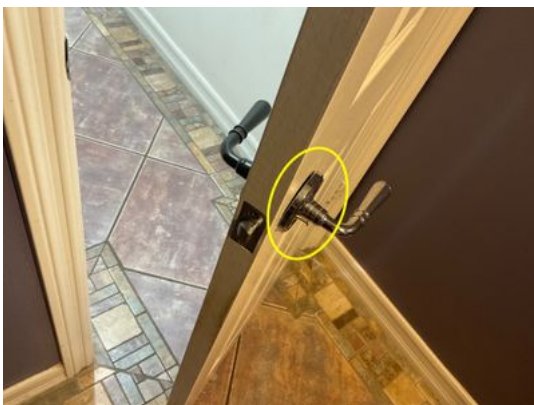
Door handle is loose.

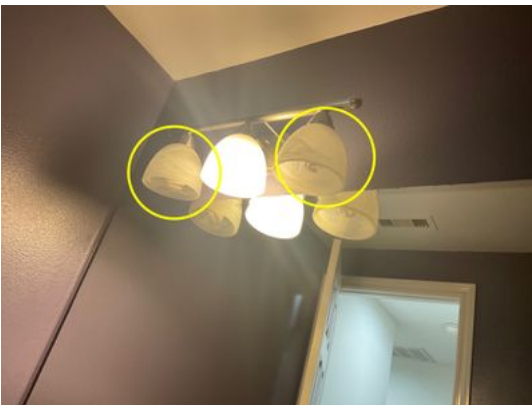
Lights do not turn on at fixture above sink.

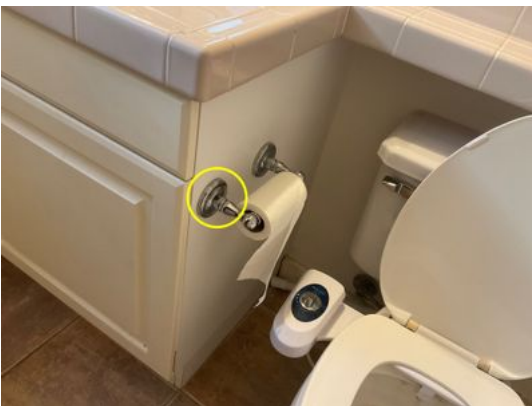
Toilet paper holder is loose.

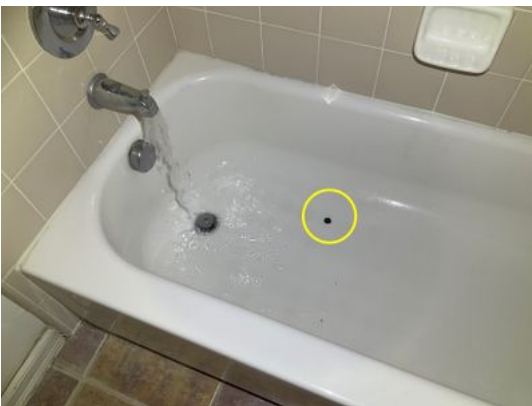
Tub finish is damaged.

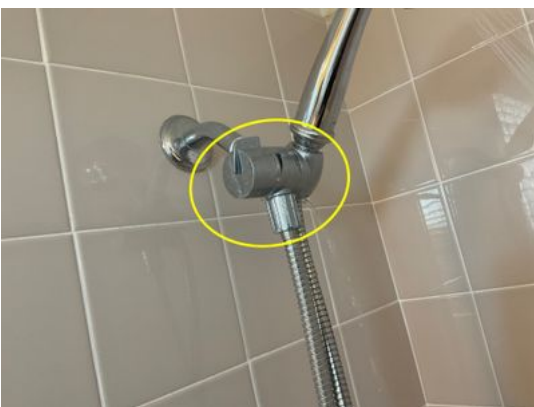
Shower head leaks.

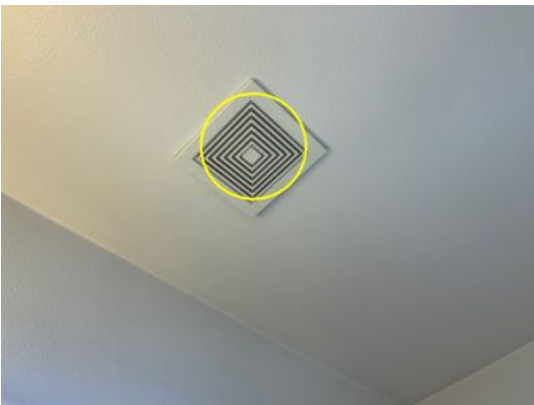
Ventilator fan is dirty.

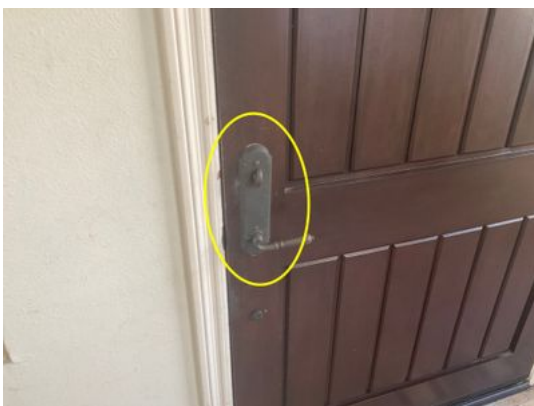
Front door does not open, hardware is broken.

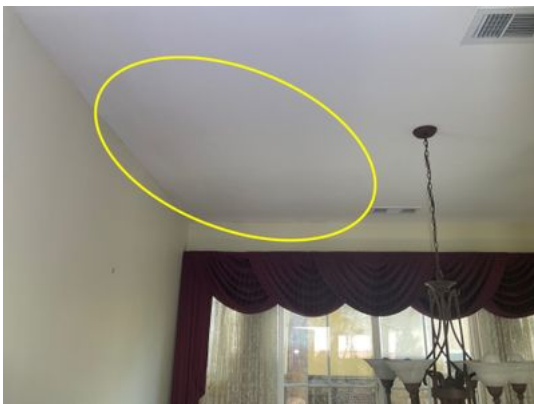
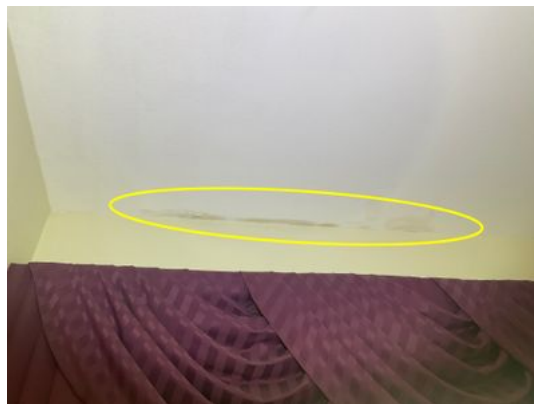
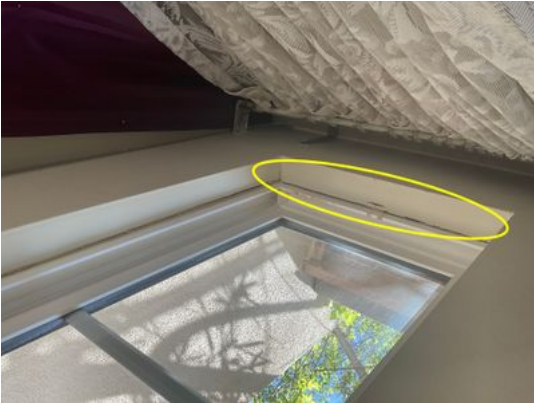
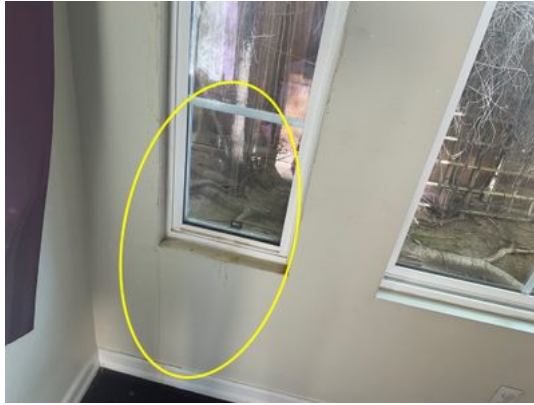
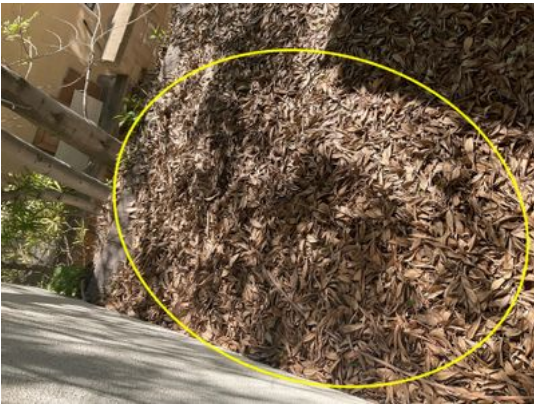
Water damage at ceiling and wall in dining room. High levels of moisture detected with infrared scan. Water has come down through wall at top of window. Roof is covered in leaves above this area. Recommend further evaluation by a qualified and licensed roofer.

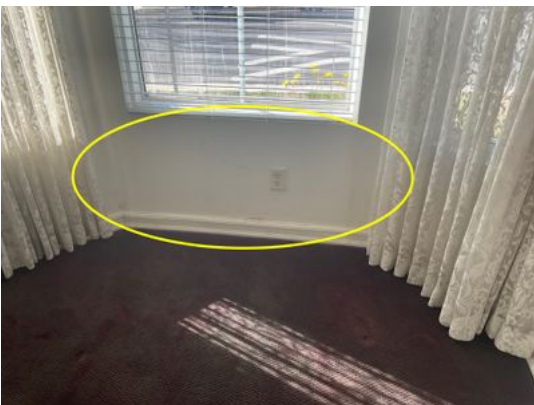
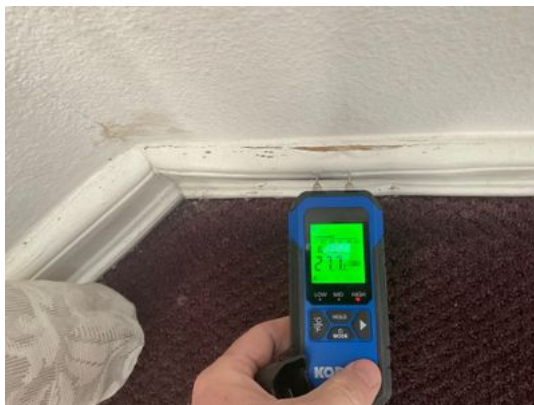
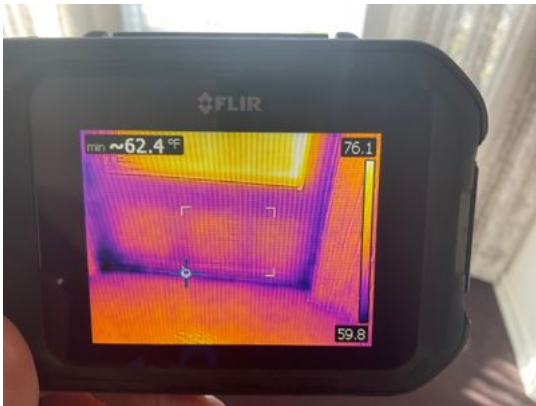
Water damage at wall below window in living room. High levels of moisture detected with moisture meter.

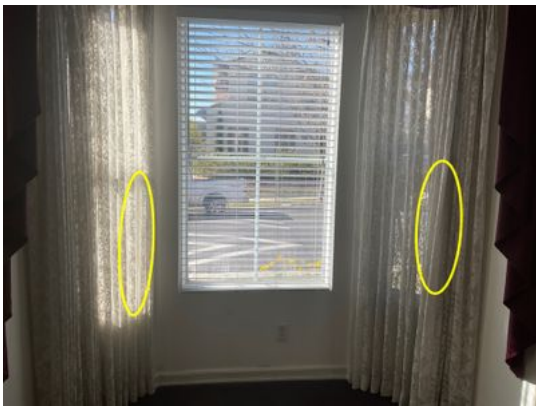
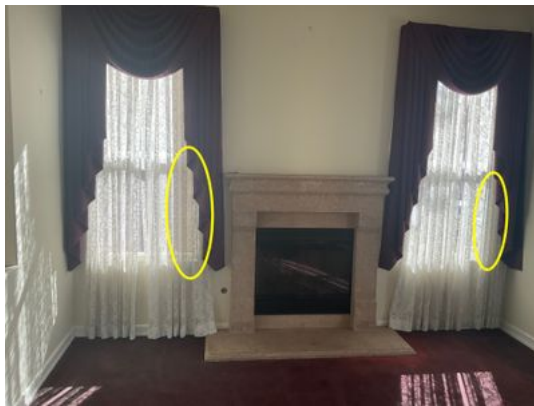
Window balance springs are damaged in living room.

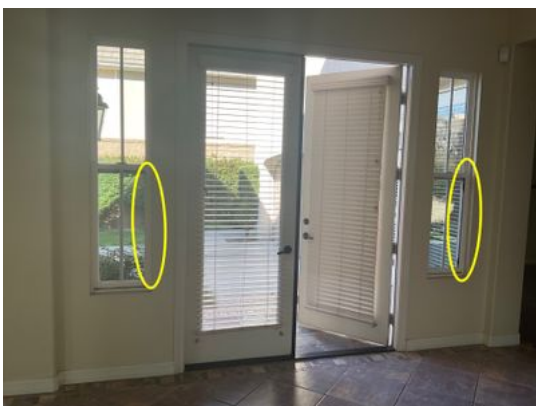
Window balance springs are damaged in hallway.

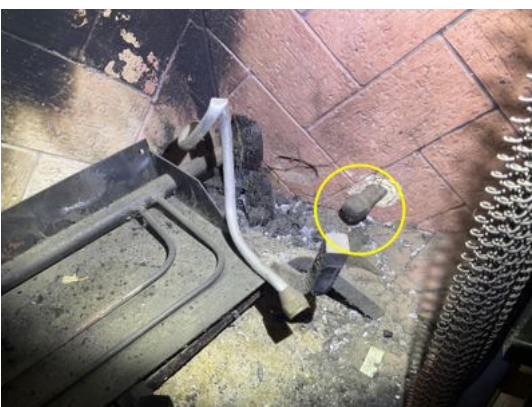
Gas pipe is capped.

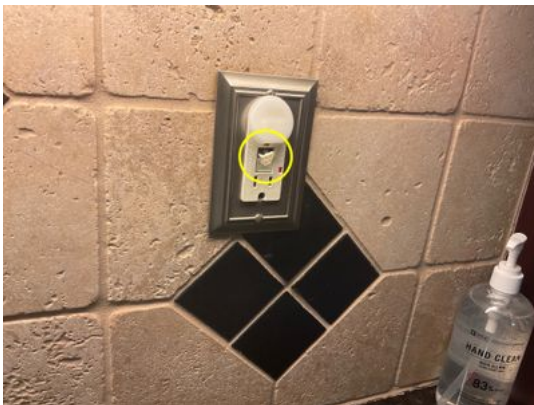
Electrical outlet reset button is broken.

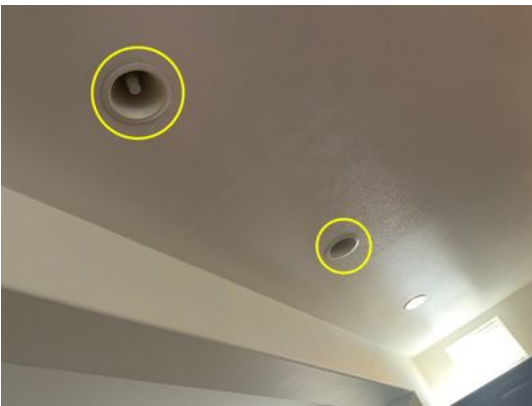
Light fixtures do not turn on at ceiling.
