General Home Inspection

1234 Busy St
Fullerton, CA 92833

OC Home Inspect

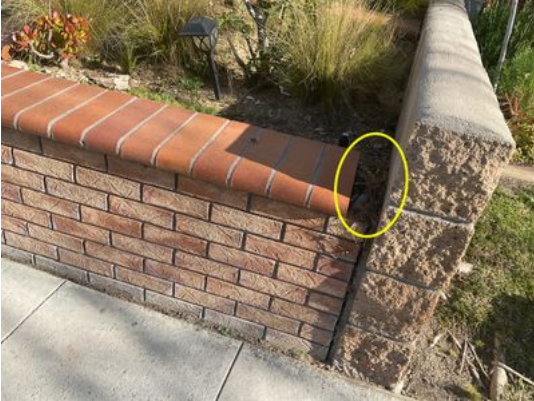
Brick cap is missing at planter wall front of house.

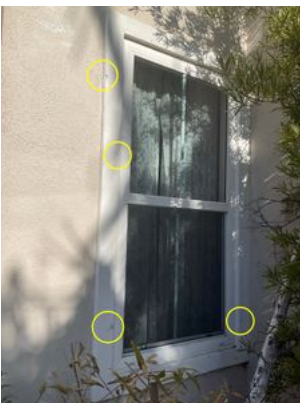
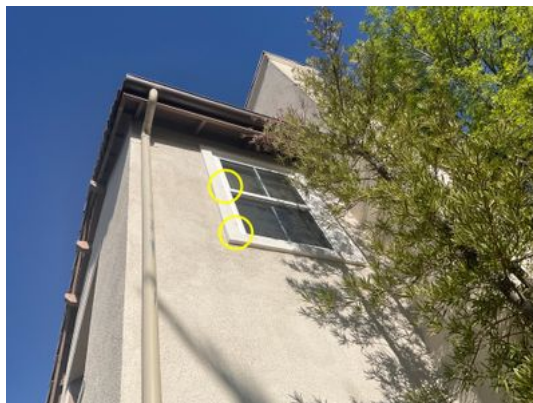
Stucco is damaged at window trim front of house.

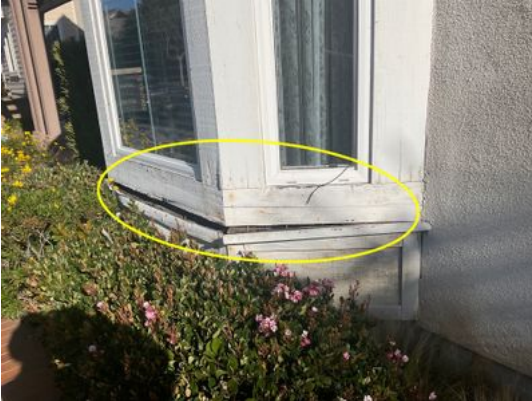
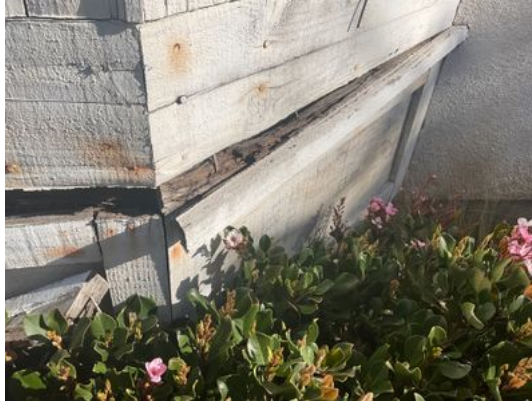
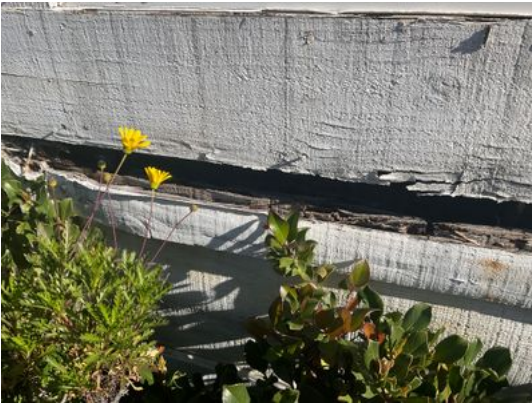
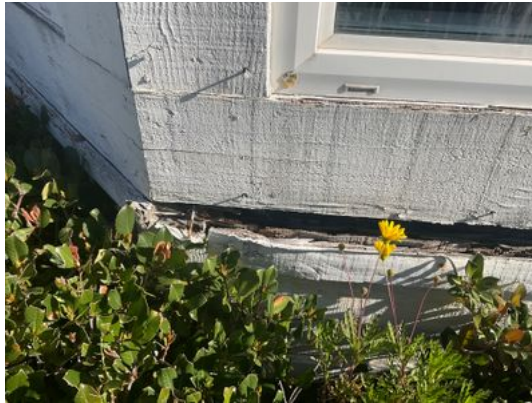
Comment 8

Water damage at siding around window front of house.

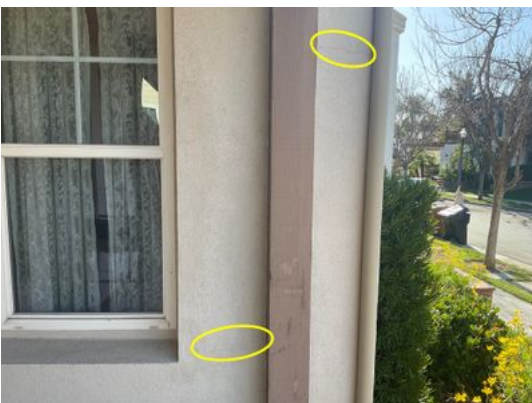
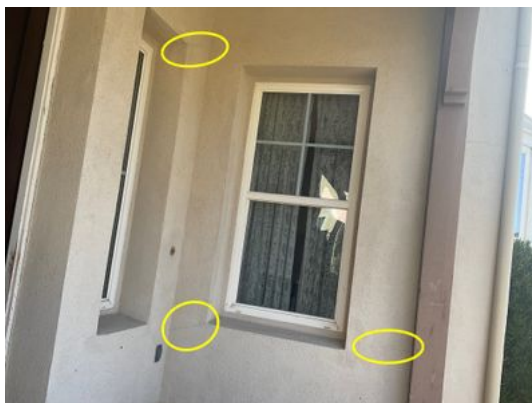
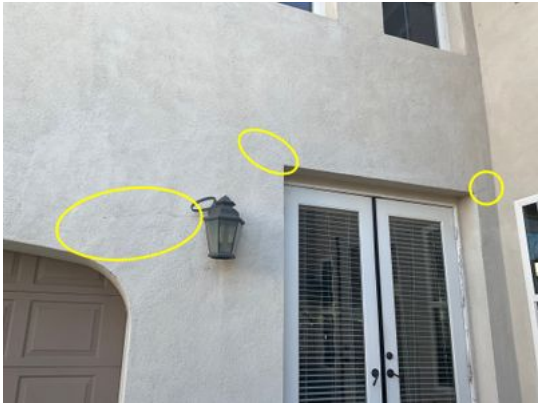
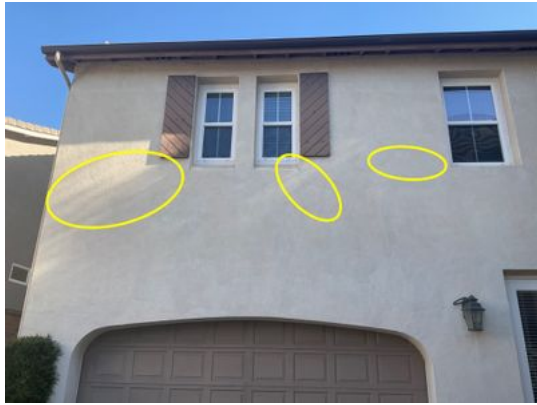
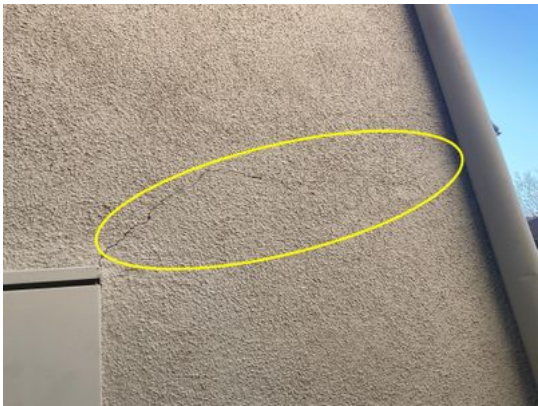
Comment 9

Stucco cracks on exterior walls.

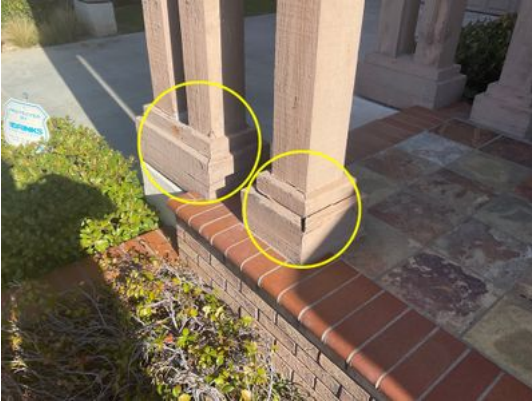
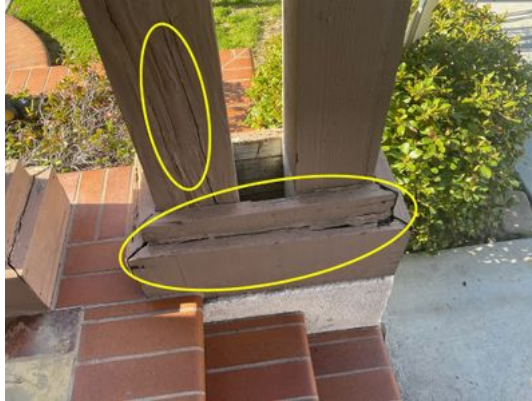
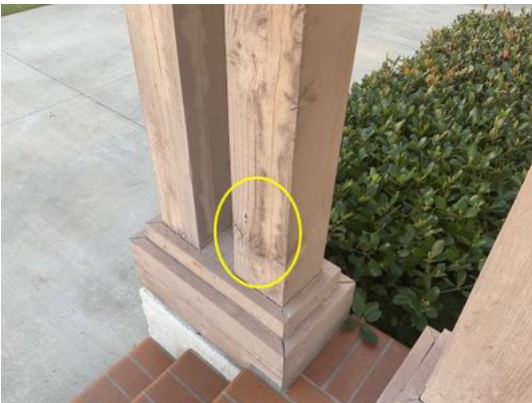
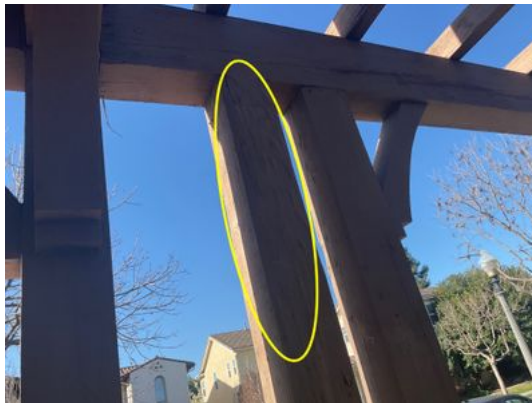
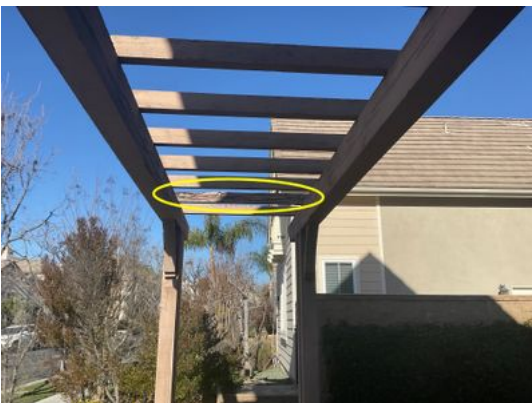
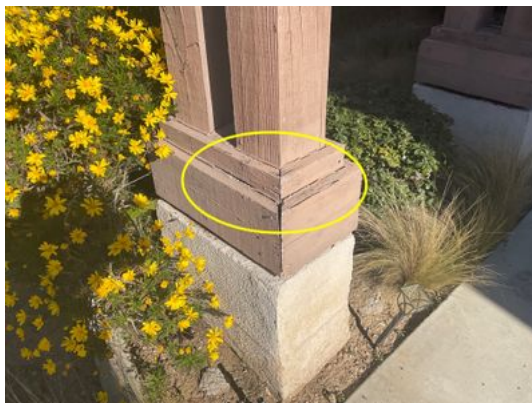
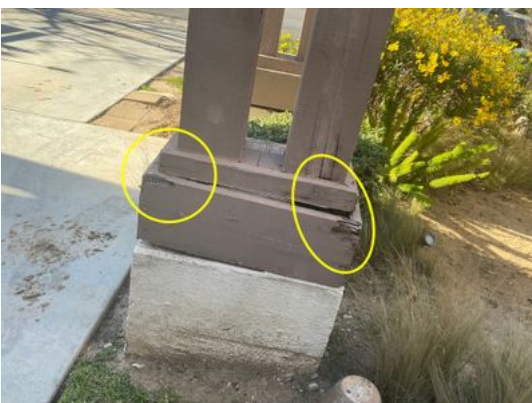
Comment 10

Water damage at pergola in several areas at front of house.

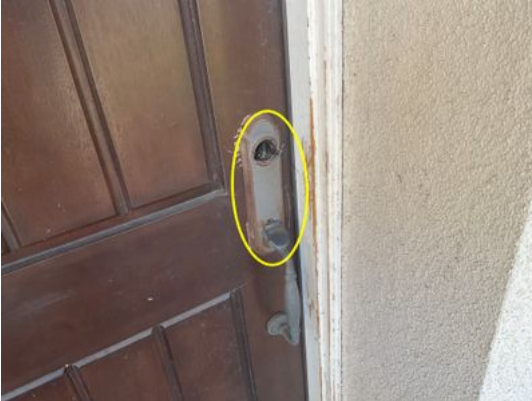
Comment 11

Hardware is broken at front door.

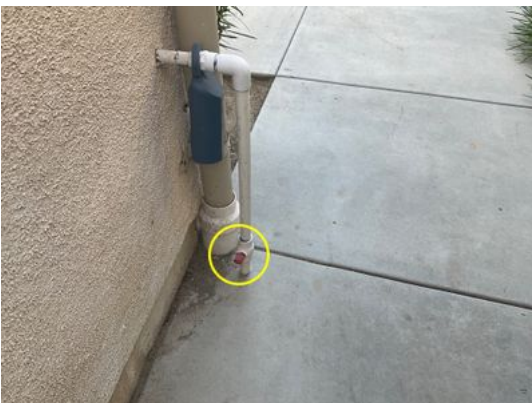
Handle levers broken off at water valve left side of house.

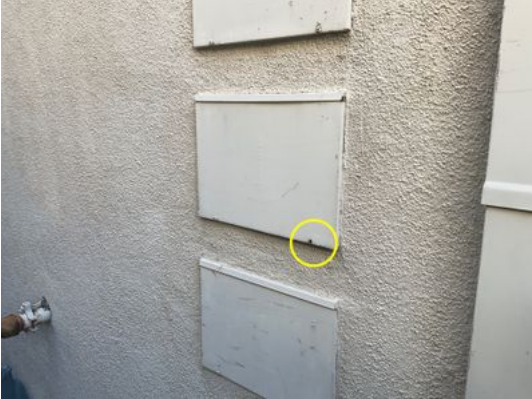
Comment 14

Screw is missing at cover for telephone box left side of house.

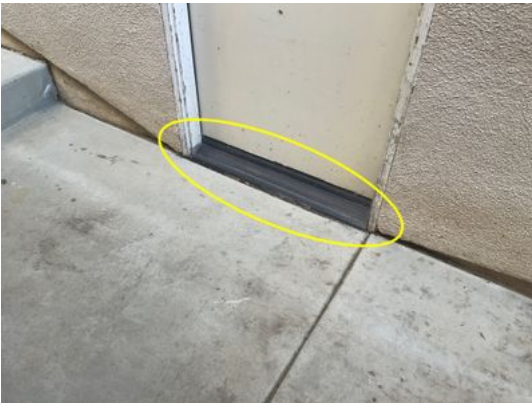
Comment 15

Finished grade is at or above threshold of door on left side of house.

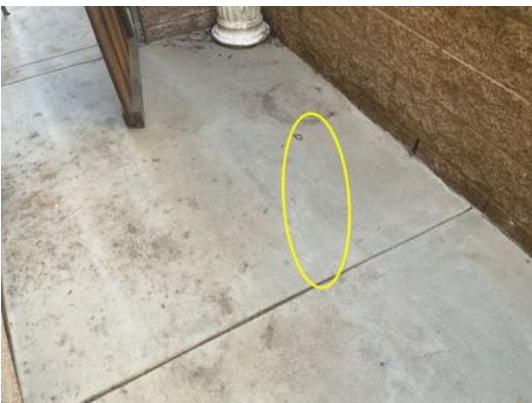
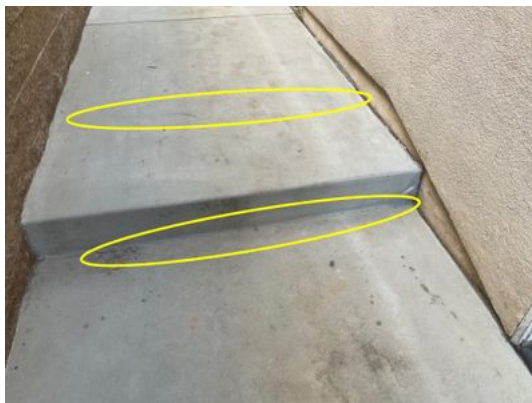
Comment 16

Concrete is cracked at walkway left side of house.

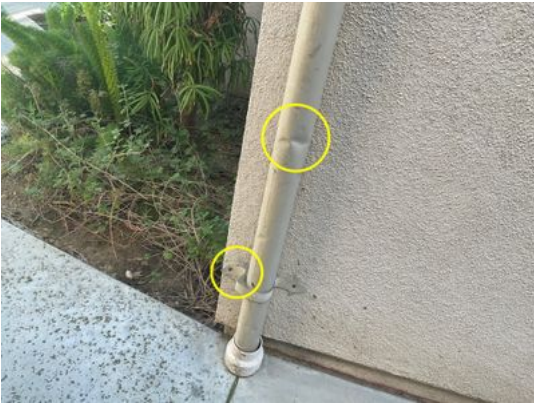
Comment 17

Downspout is dented and strap is loose on left side of house.

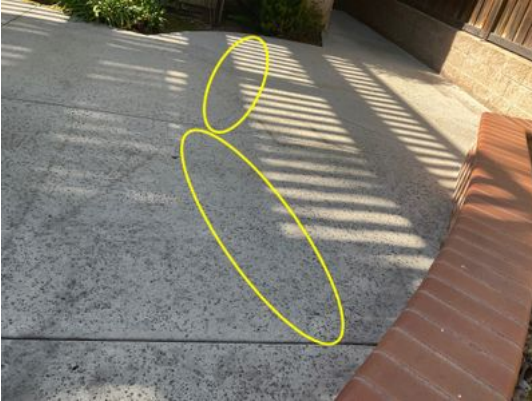
Concrete is cracked at patio back of house.

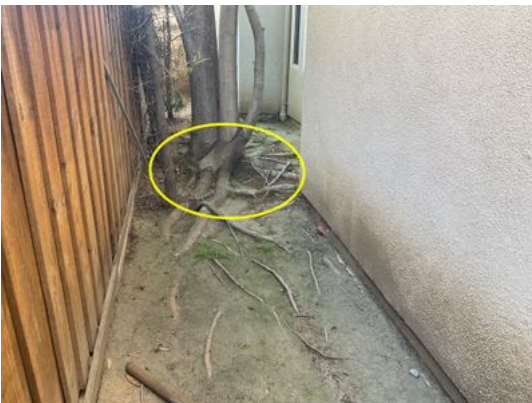
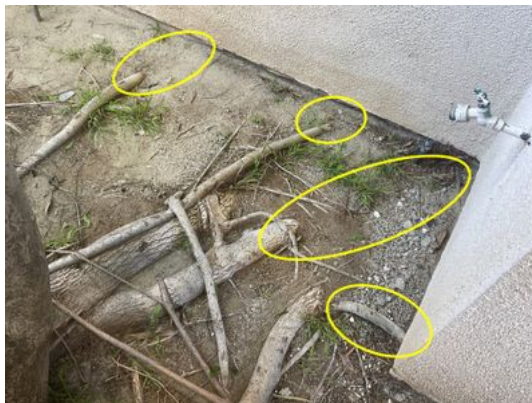
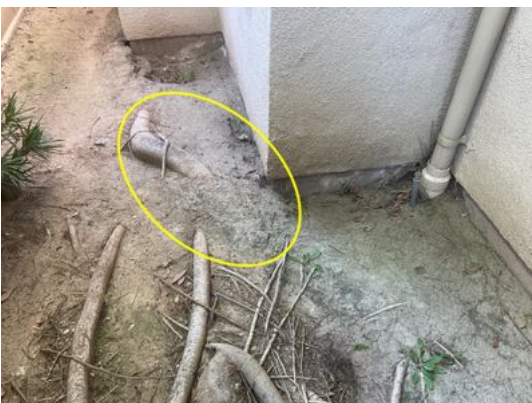
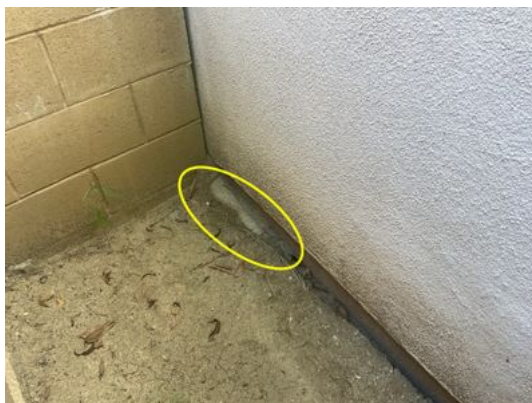
Comment 20

Tree planted close to right side of house. Tree roots growing towards and under foundation.

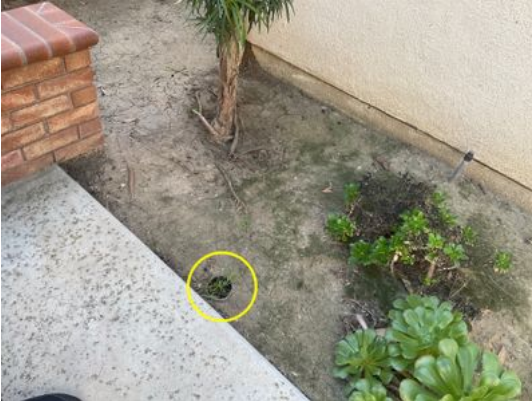
Comment 21

Drain grate/cover is missing at planter back of house.

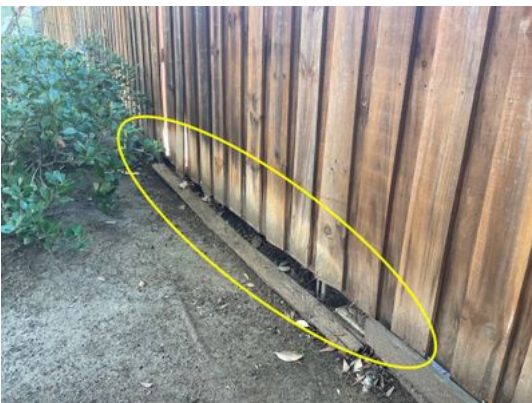
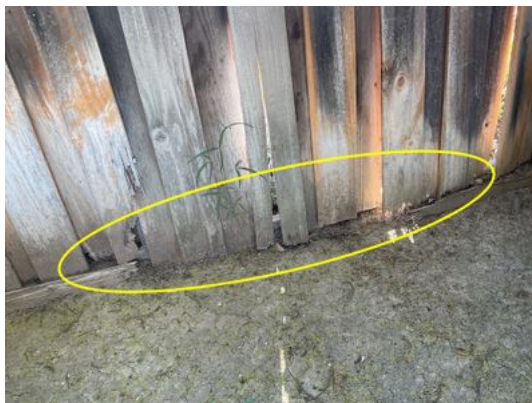
Water damage at fencing back of house. Fence installed against ground soil.

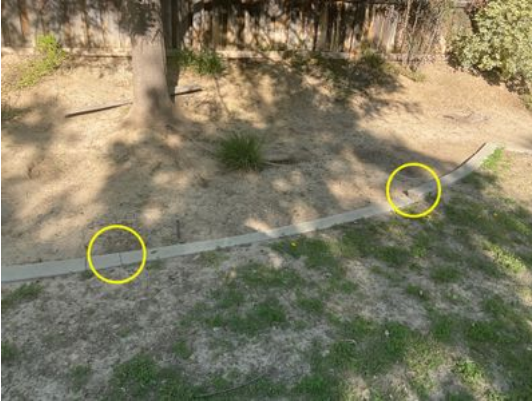
Comment 24

Planter curb is cracked and lifted at back of house.

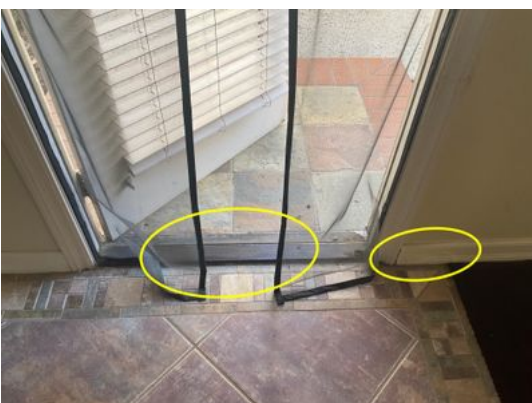
Finished grade is at or above threshold of door at back of house. Water damage at baseboard inside house.

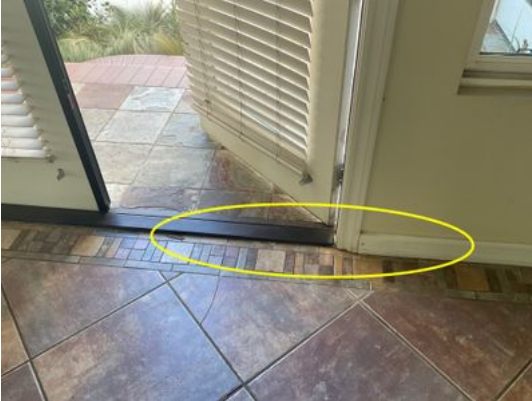
Comment 27

Finished grade is at or above threshold of door at side porch. Water damage at baseboard inside house.

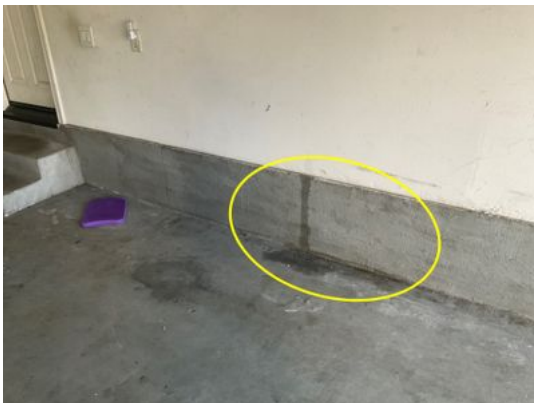
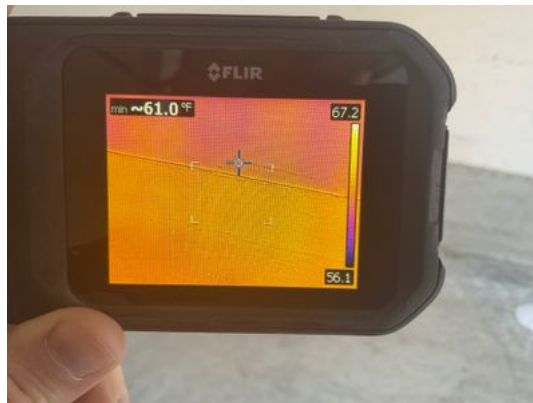
Water stain at wall and foundation right side of garage. Low levels of moisture detected with moisture meter. A skim coat has been applied to the foundation.

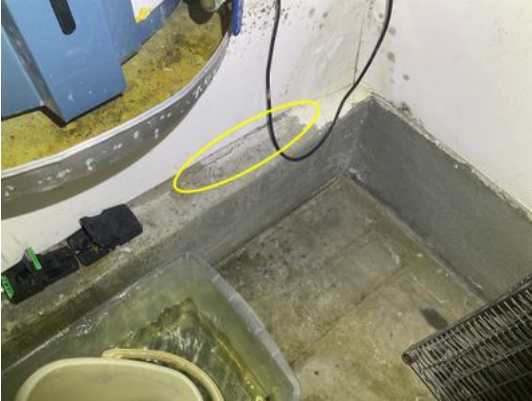
Comment 34

Concrete cracked at foundation back of garage below water heater.

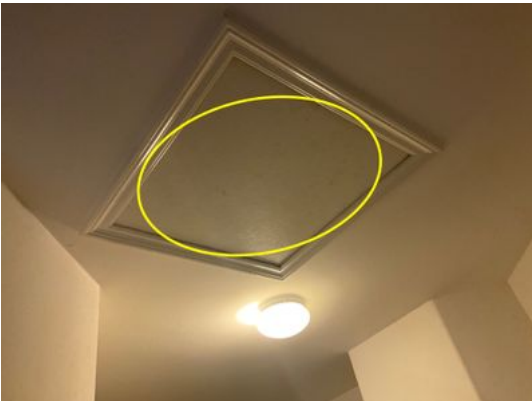
**Comment 37
Defect**

Insulation blanket is not installed above attic hatch.

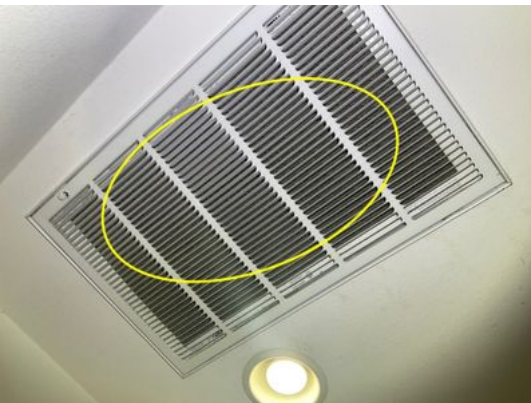
Comment 40
Defect

Return air filter is dirty.

Furnaces over 10 years old should be checked, cleaned and serviced yearly by a licensed contractor.

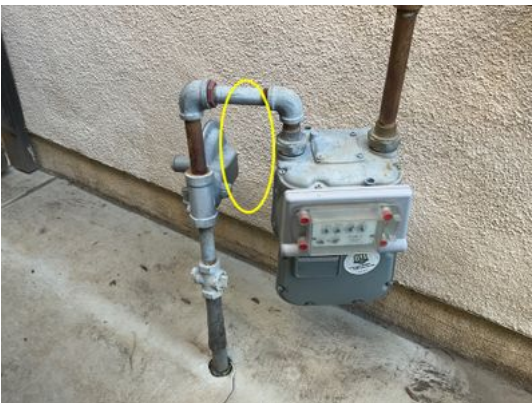
Comment 46
Safety

Key/wrench is not present at main gas valve for emergency shut off.

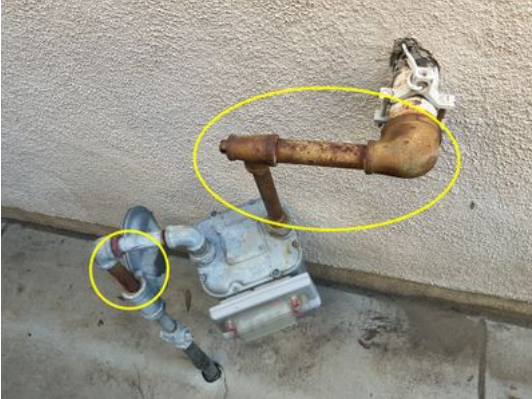
Comment 47

Gas pipe is rusty at meter.

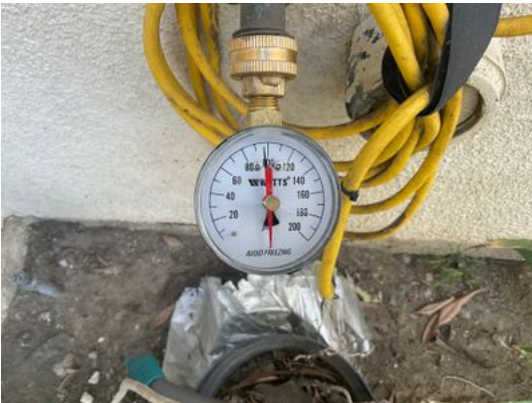
Comment 48

Water pressure is higher than recommended. This may cause leaks.

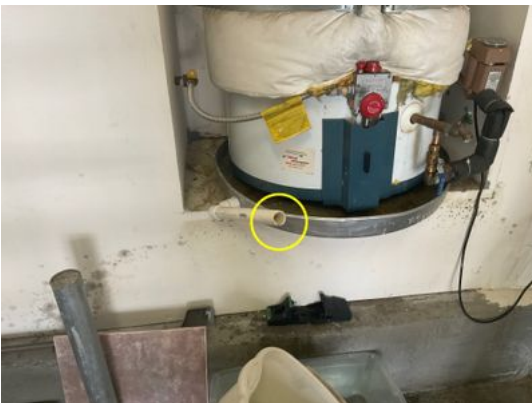
Drain pan discharges to garage floor.

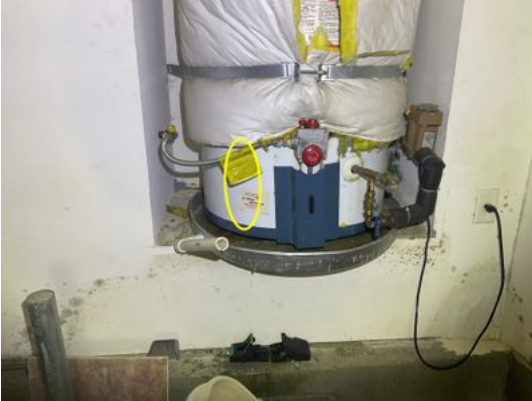
Comment 52

Drip leg(sediment trap) is not installed.

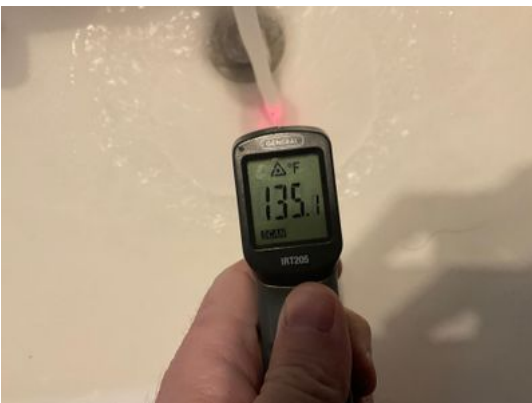
Hot water temperature at fixtures measured above 120 degrees.

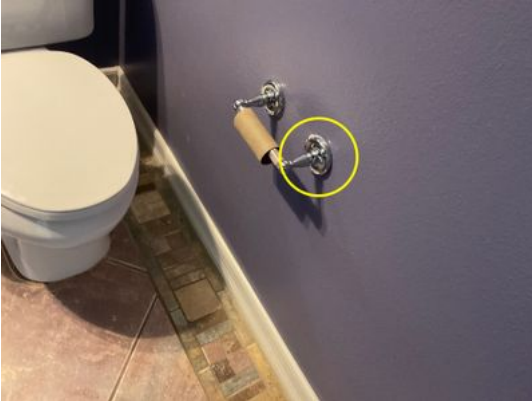
Toilet paper holder is loose.

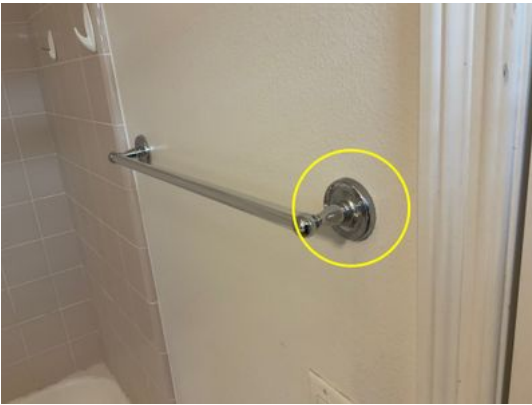
Towel rack is loose.

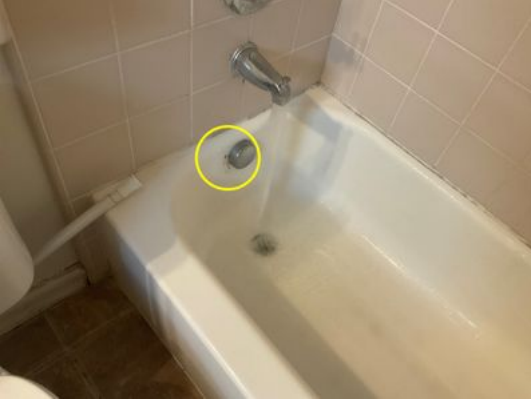
Tub is rusty around overflow.

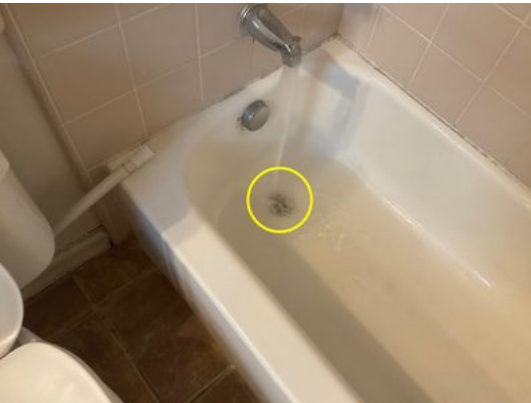
Comment 62

Tub drain stopper is missing.

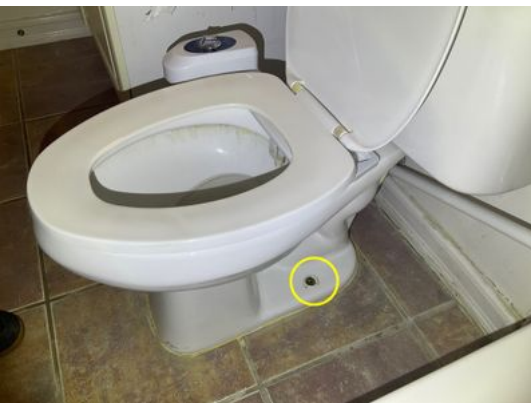
Comment 63

Toilet floor bolt cap(s) are not installed.

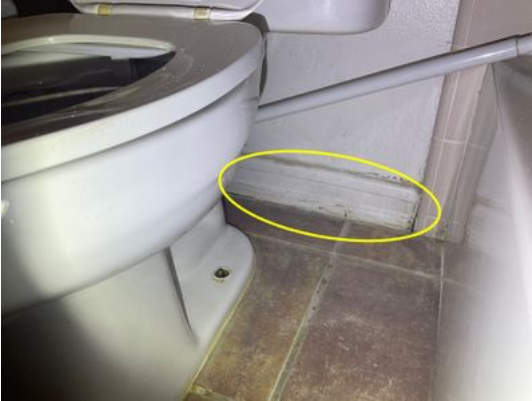
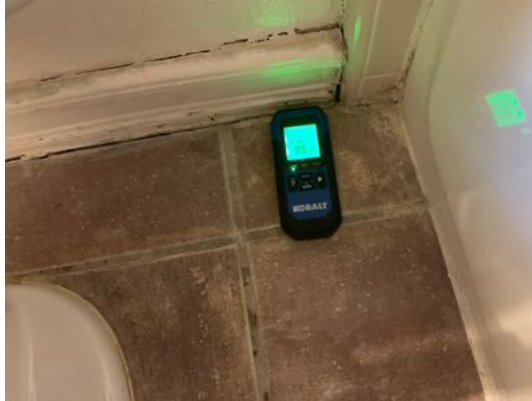
Water damage at baseboard behind toilet. Low levels of moisture detected with moisture meter.

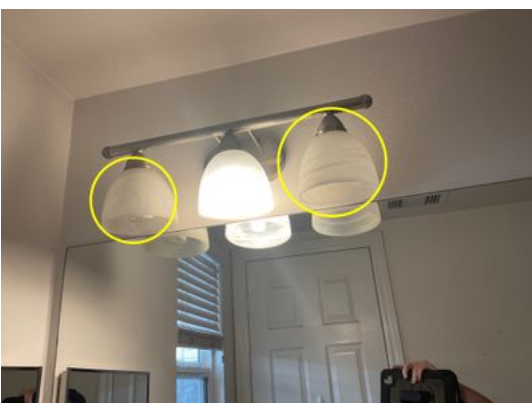
Comment 66

Lights do not turn on at fixture above sink.

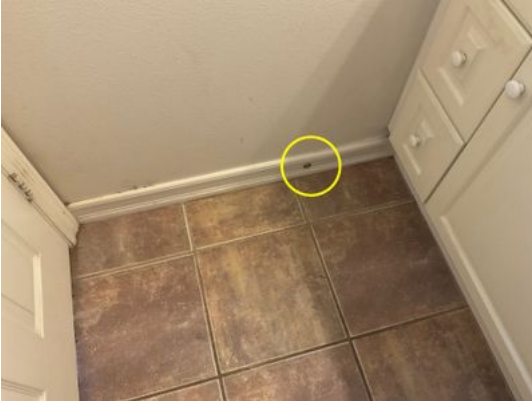
Comment 67

Door stopper is missing.

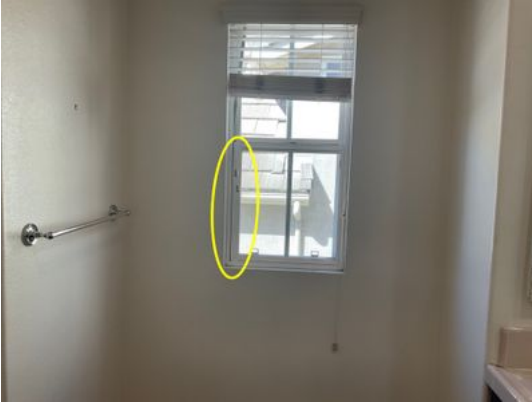
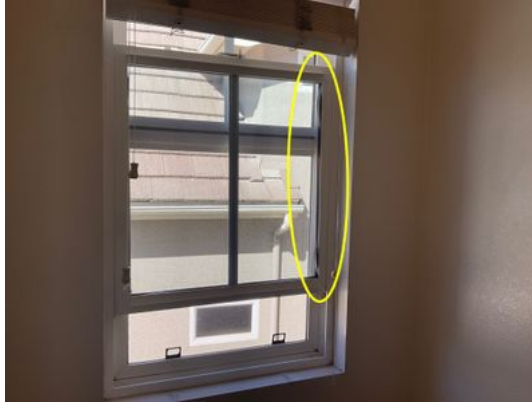
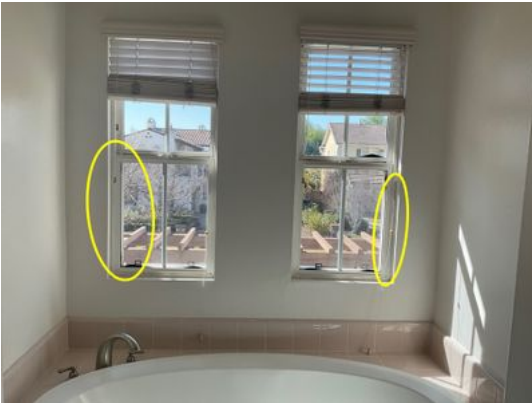
Window balance springs are damaged.

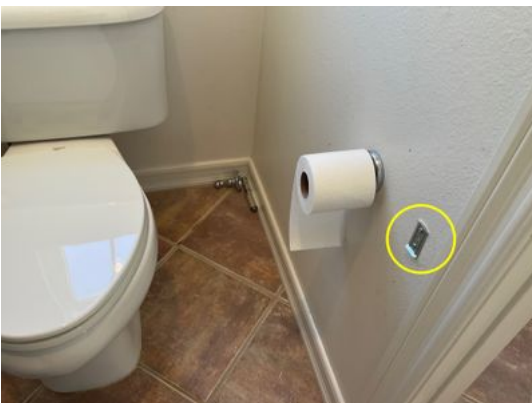
Comment 69

Toilet paper holder is detached.

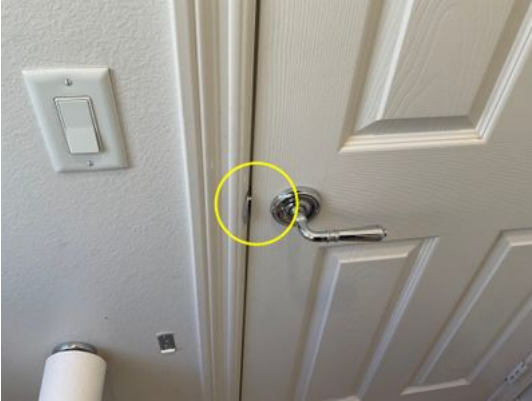
Comment 70

Door to water closet does not latch.

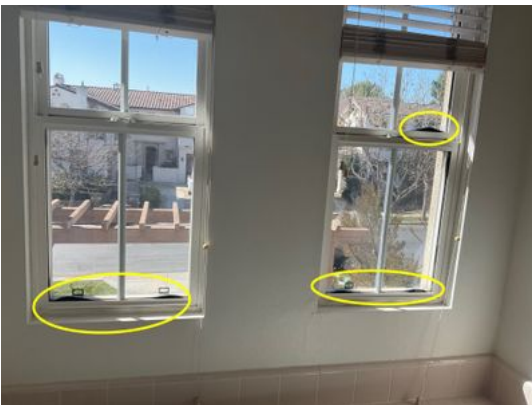
Comment 71

Window seals are loose.

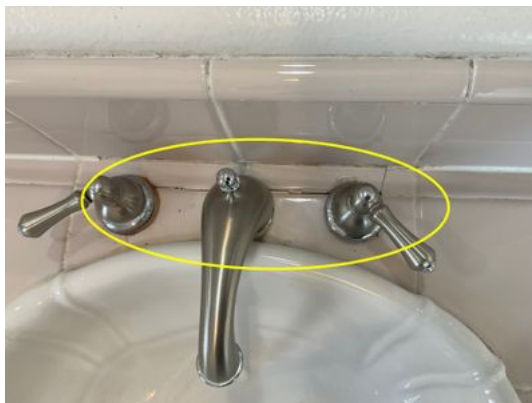
Comment 72

Tile cracked at sinks.

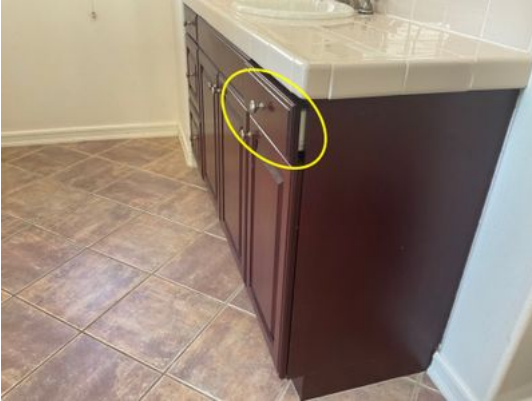
Comment 73

Drawer catches at cabinet.

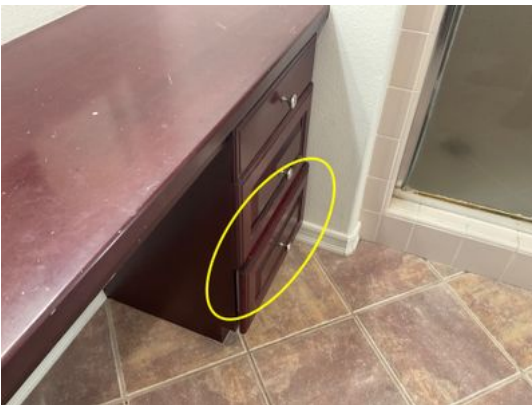
Comment 74

Drawer does not shut fully at cabinet.

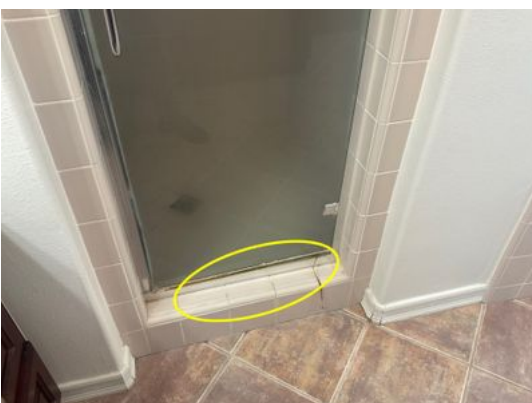
Comment 75

Seal is damaged at bottom of shower door.

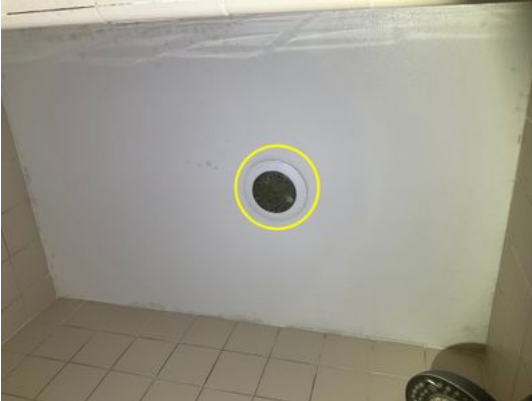
Comment 76

Light fixture does not turn on in shower.

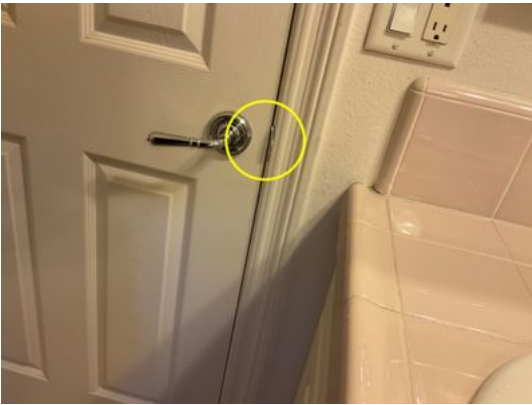
Door does not latch.

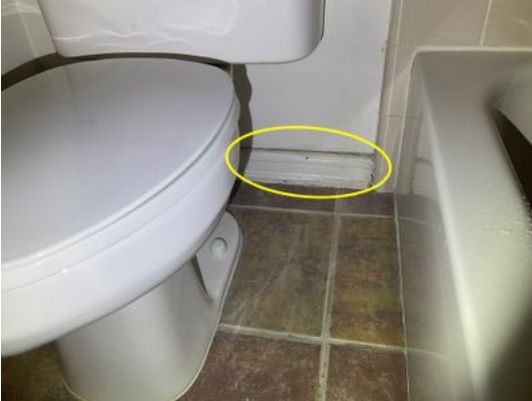
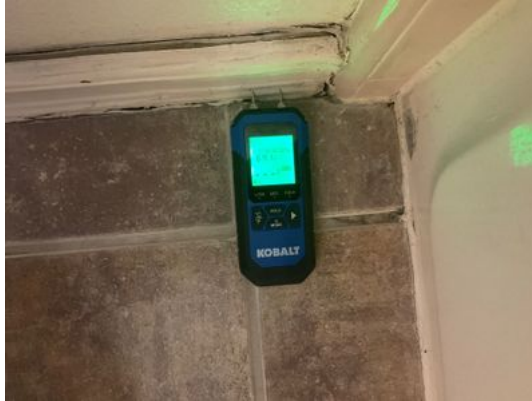
Water damage at baseboard behind toilet. Low levels of moisture detected with moisture meter.

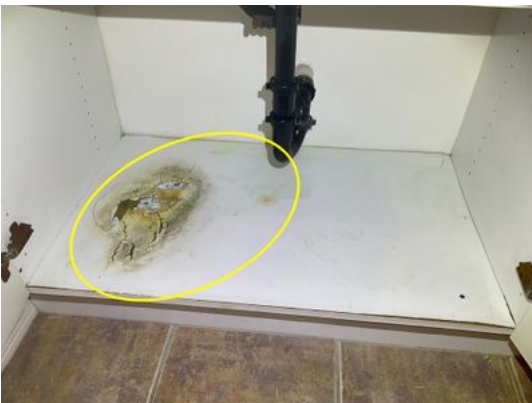
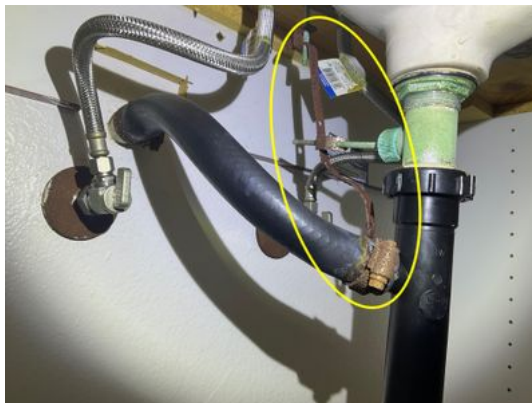
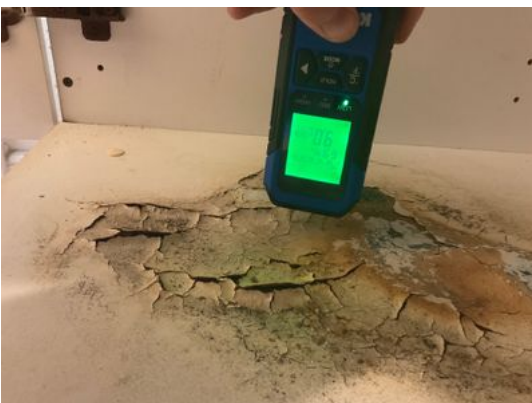
Comment 81

Water damage at cabinet under left sink. Hardware above is rusty. Low levels of moisture detected with moisture meter.

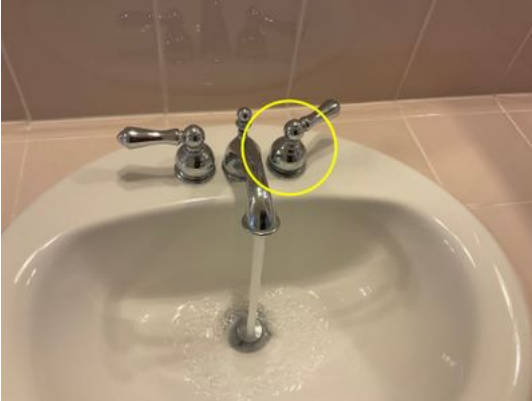
Comment 82

Stop is broken on cold valve at right sink.

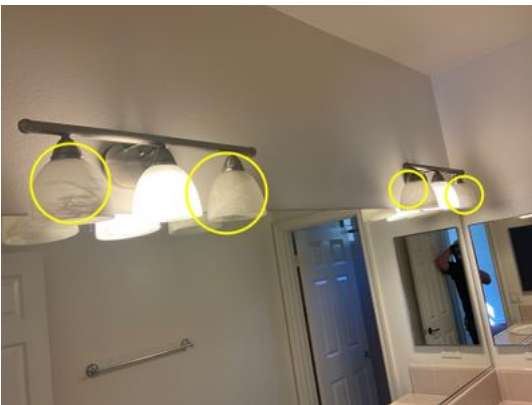
Comment 83

Lights do not turn on at fixtures above sinks.

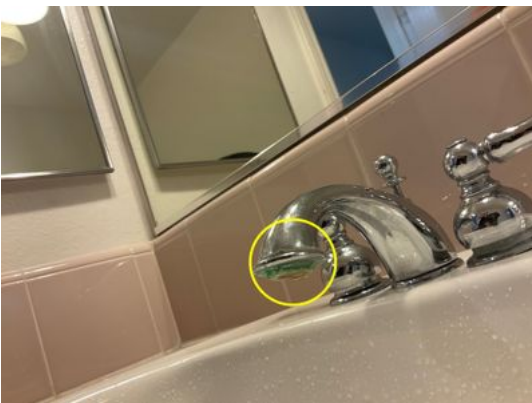
Comment 84

Faucet is corroded at left sink.

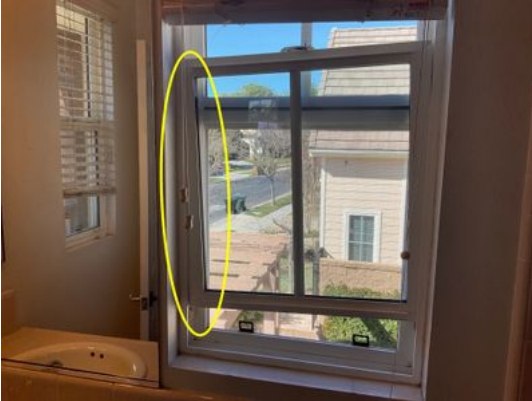
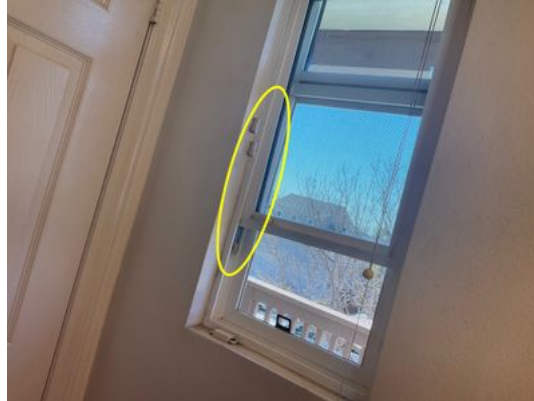
Window balance springs are damaged.

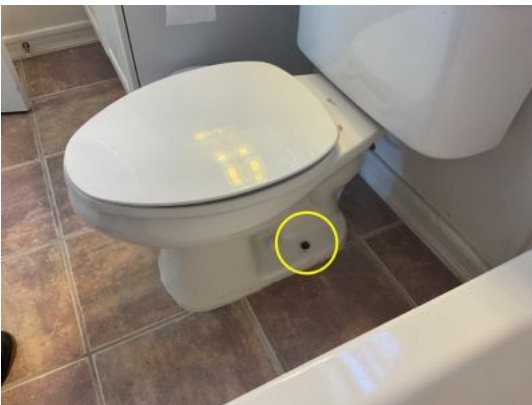
Comment 87

Toilet floor bolt cap(s) are not installed.

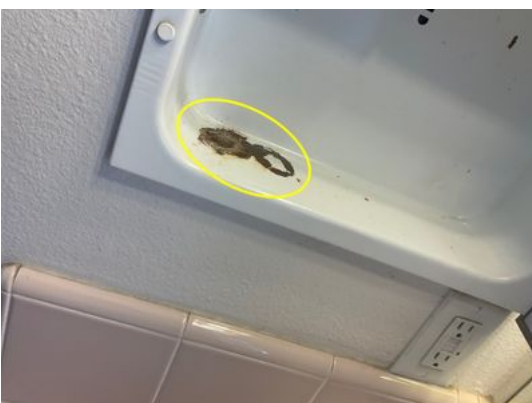
Comment 88

Medicine cabinet is rusty.

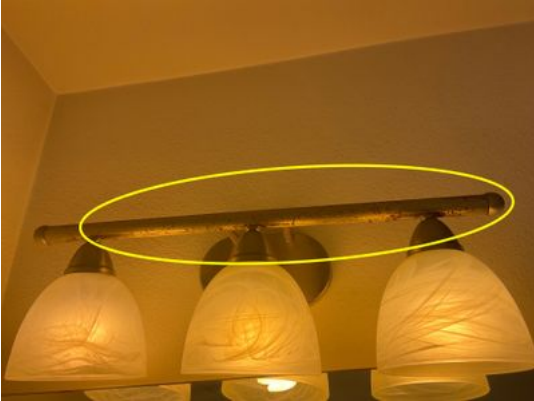
Comment 89

Light fixture is rusty.

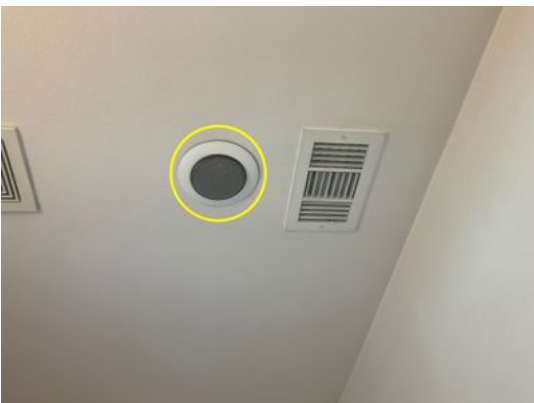
Light fixture does not turn on at ceiling.

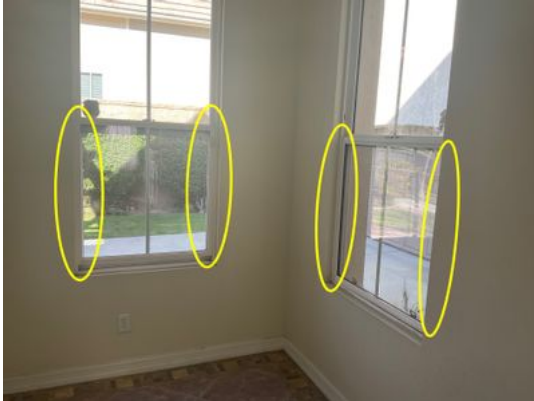
Window balance springs are damaged in entryway.

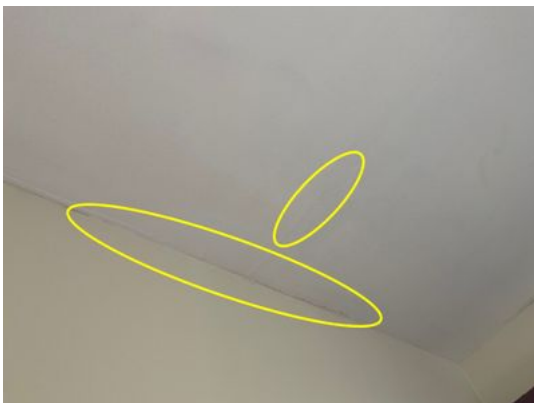
Comment 94

Water damage at ceiling and wall in dining room. High levels of moisture detected with infrared scan. Water has come down through wall at top of window. Roof is covered in leaves above this area. Recommend further evaluation by a qualified and licensed roofer.

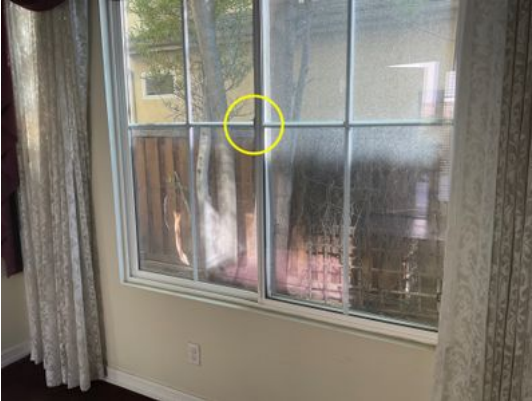
Window does not fully close and latch in dining room.

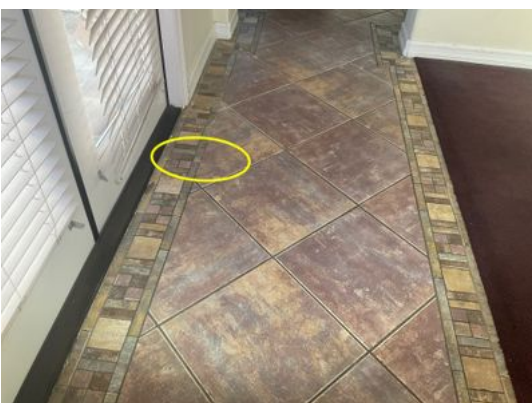
Comment 100

Flooring is cracked in hallway.

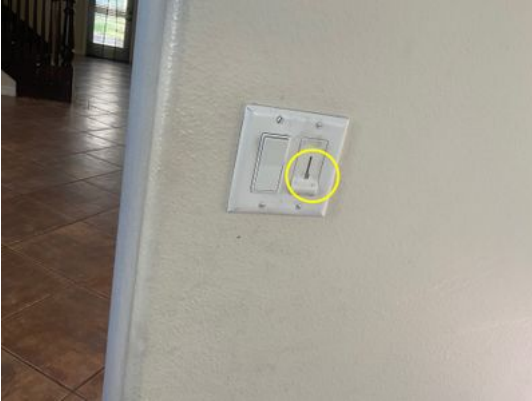
Comment 101

Knob is missing at light switch in dining room.

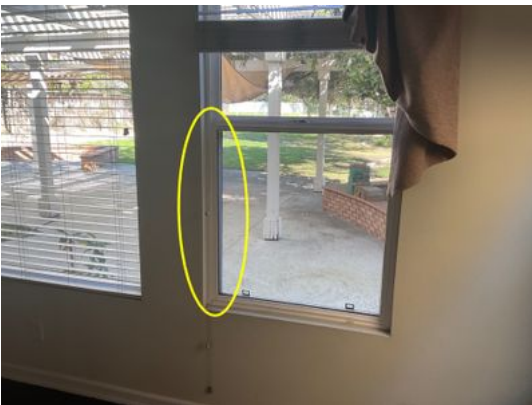
Window balance spring is damaged in family room.

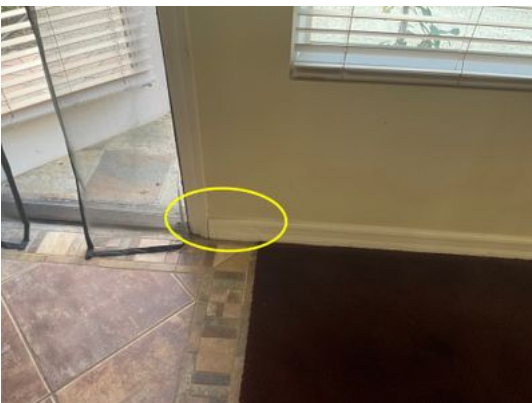
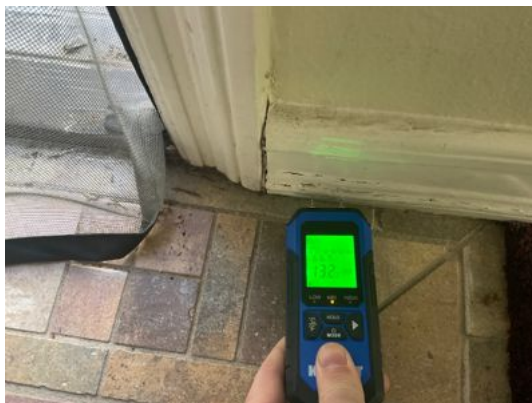
Comment 103

Water damage at baseboard inside back door. Elevated levels of moisture detected with moisture meter.

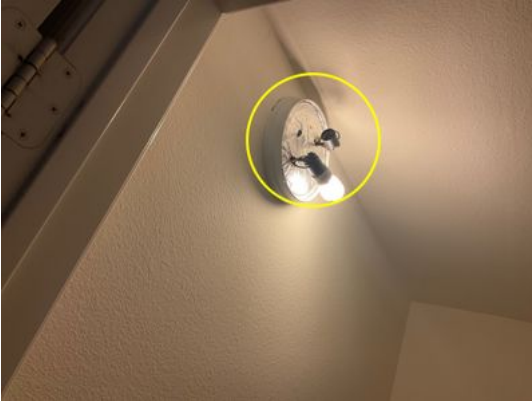
Comment 104

Lens is missing at light fixture in bedroom closet.

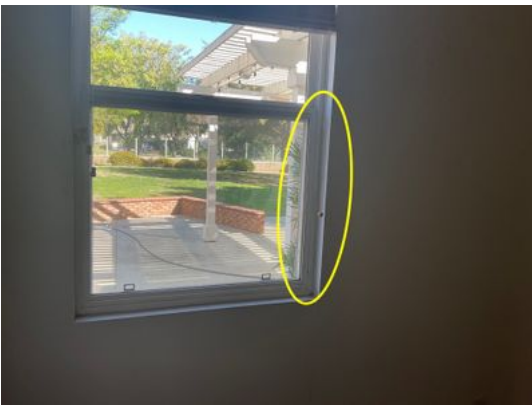
Comment 105

Window balance spring is damaged in downstairs bedroom.

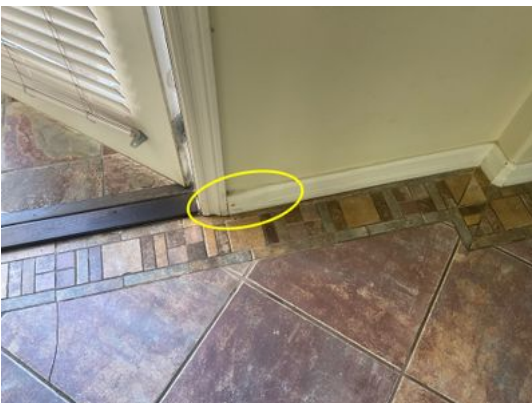
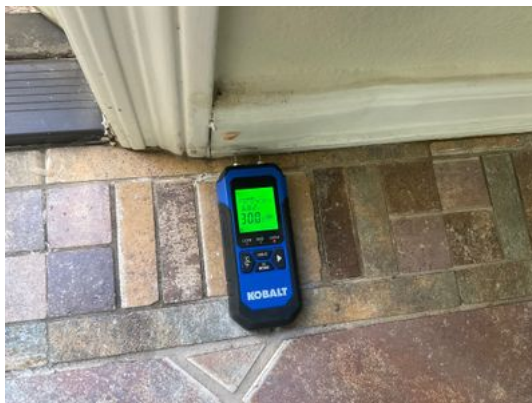
Comment 106

Water damage at baseboard inside side door. High levels of moisture detected with moisture meter.

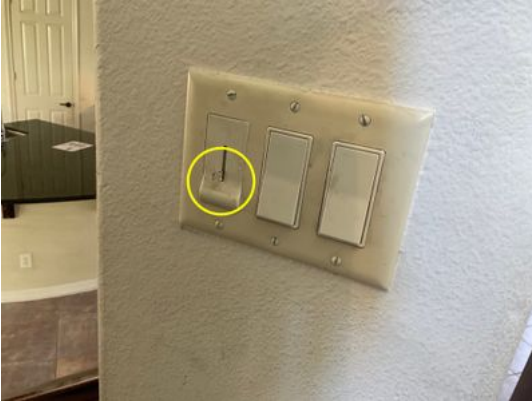
Comment 107

Switch is bent and knob is missing in stairwell.

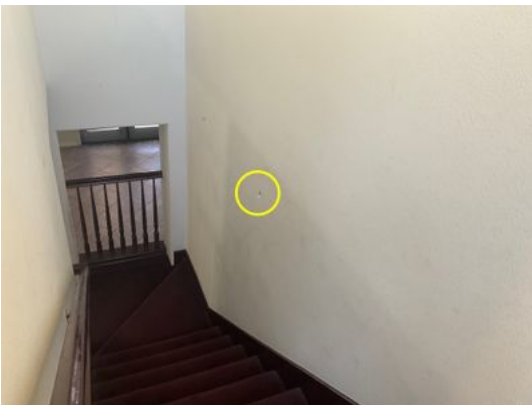
Comment 108

Drywall damaged in stairwell.

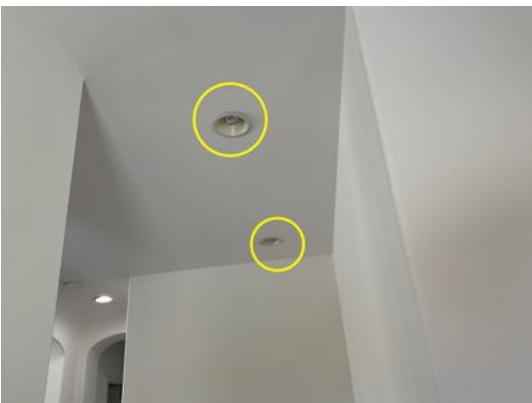
Comment 109

Light fixtures do not turn on above stairs.

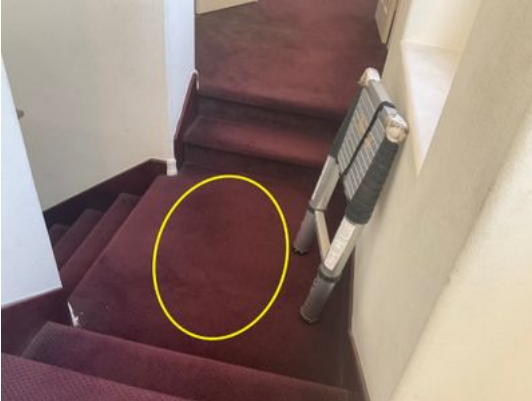
Comment 110

Subfloor creaks at landing top of stairs.

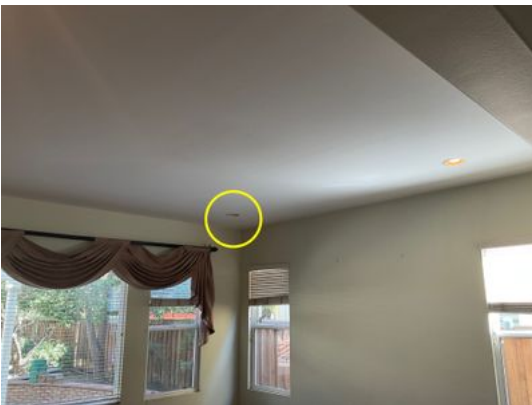
Comment 111

Light does not turn on at ceiling in family room.

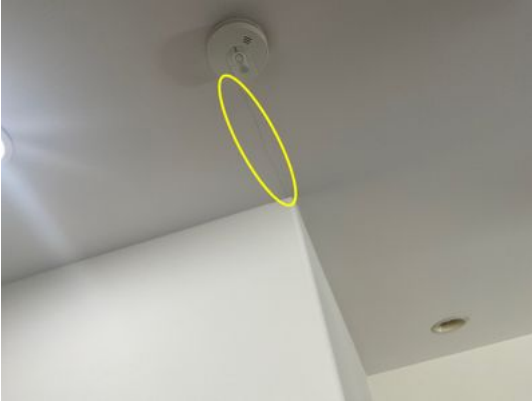
Comment 113

Drywall crack at ceiling upstairs.

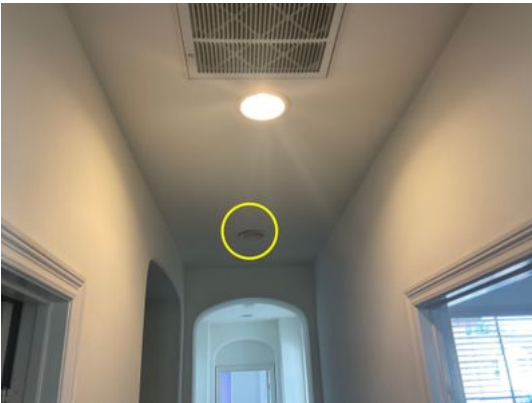
Comment 114

Light fixture does not turn on at ceiling in upstairs hallway.
