General Home Inspection

1234 Busy St
Fullerton, CA 92833

OC Home Inspect

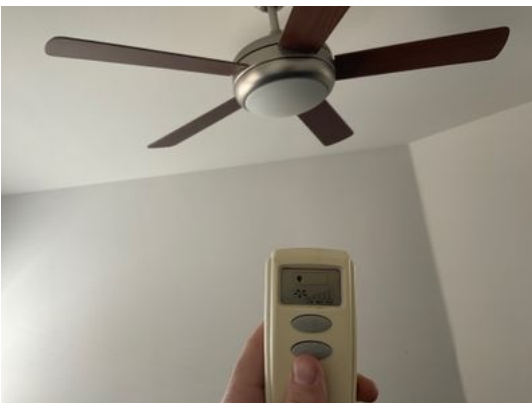
Comment 115

Battery dead could not turn on ceiling fan in bedroom.

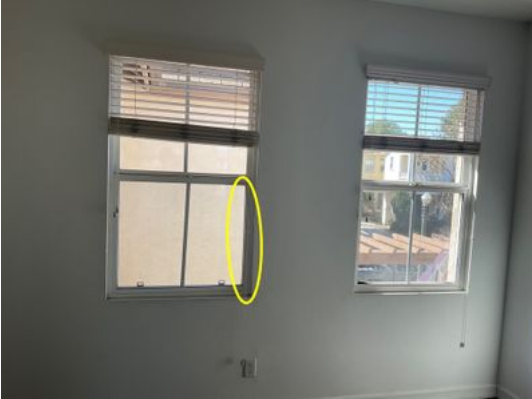
Comment 116

Window balance spring is damaged in bedroom.

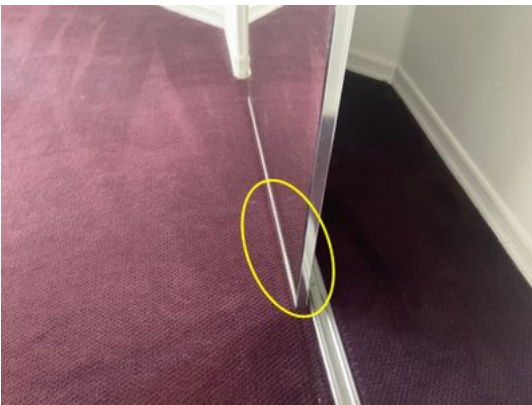
Comment 117

Closet door is off track in bedroom.

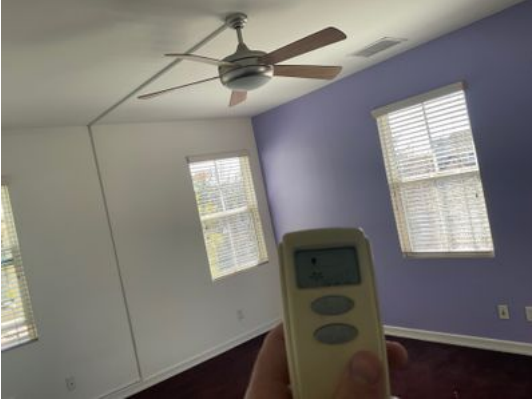
Comment 119

Battery dead could not turn on ceiling fan in bedroom.

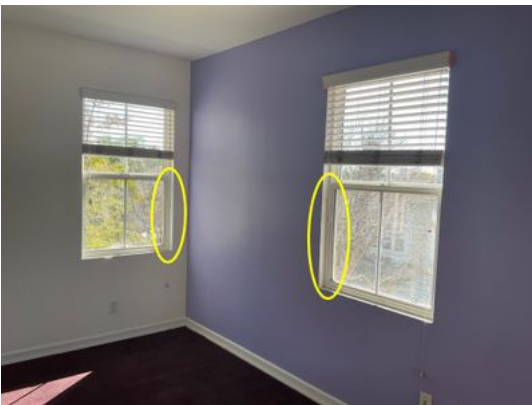
Comment 120

Window balance springs are damaged in bedroom.

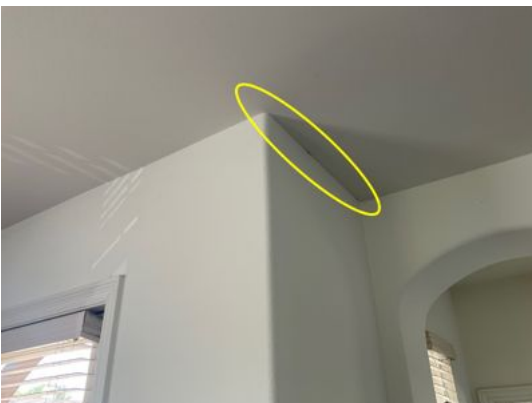
Comment 121

Drywall crack at ceiling upstairs bedroom.

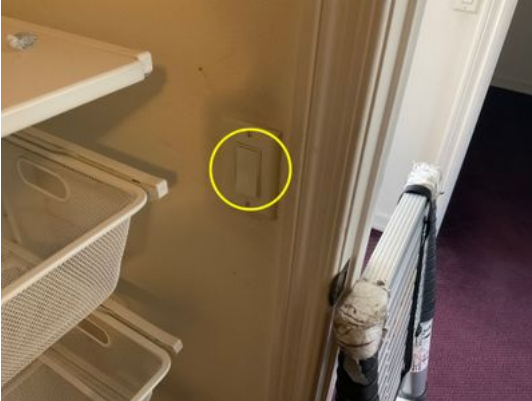
Comment 122

Light switch is broken in master closet.

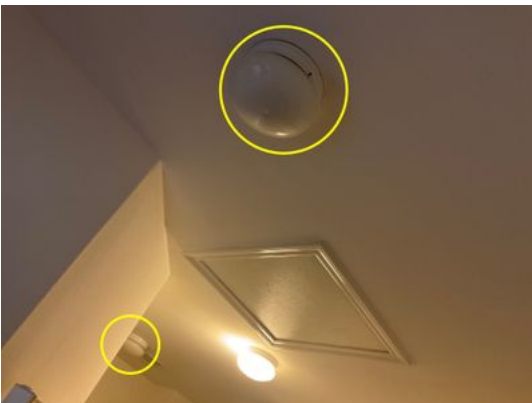
Comment 123

Light fixtures do not turn on at ceiling in master closet.

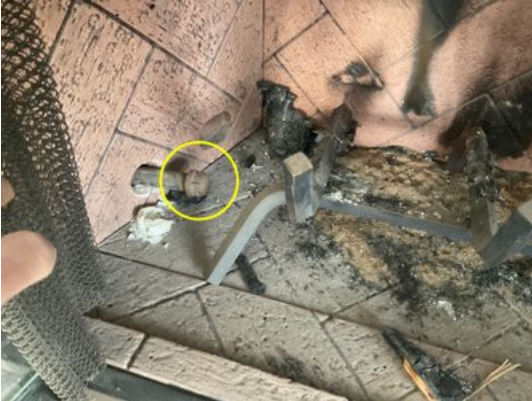
Comment 125

Gas is capped.

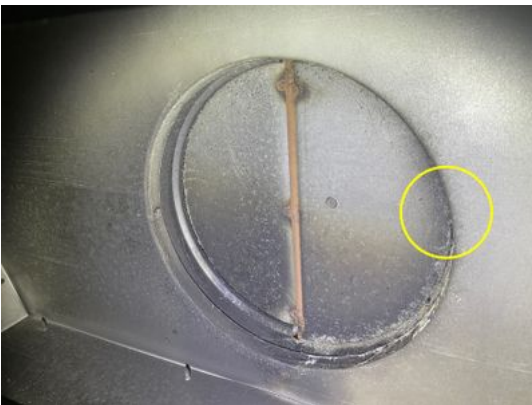
Comment 126

Damper clamp is not installed.

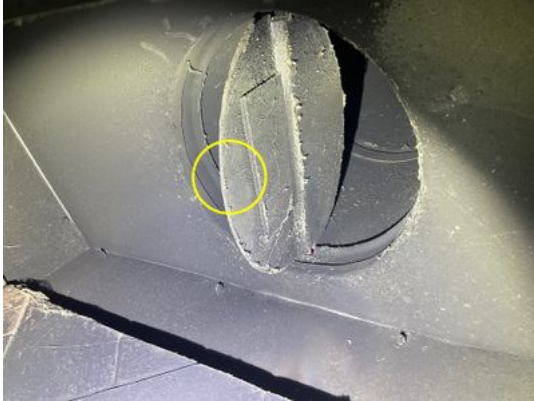
Damper clamp is not installed.

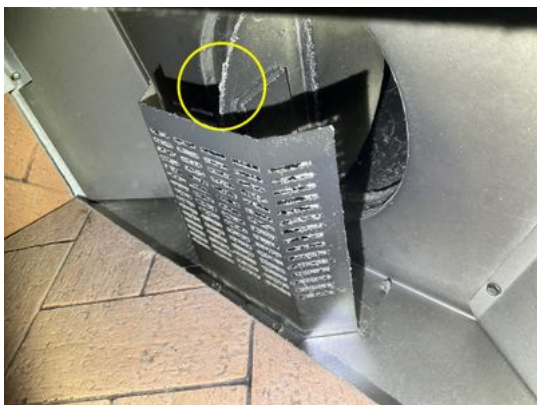
Damper clamp is not installed.

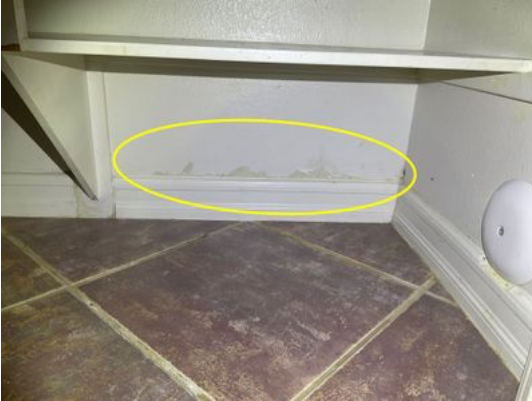
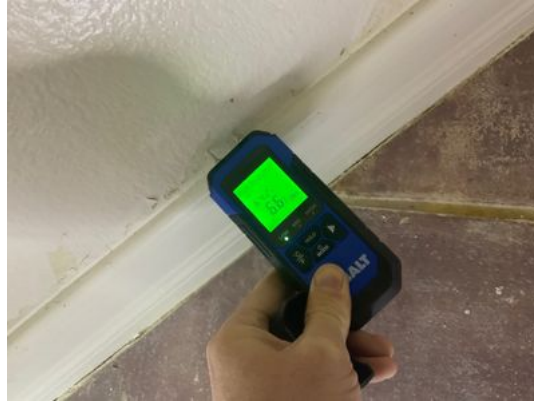
Paint peeling at wall inside pantry. Low levels of moisture detected with moisture meter.

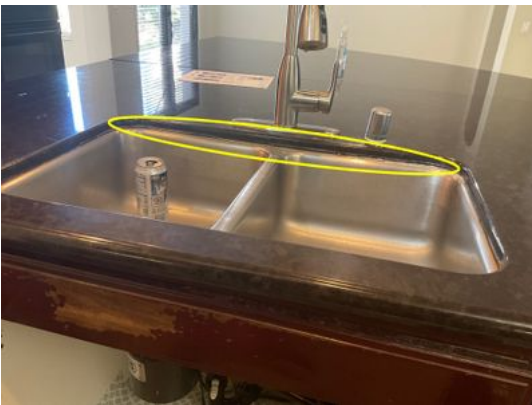
Comment 134

Gap in caulking at sink.

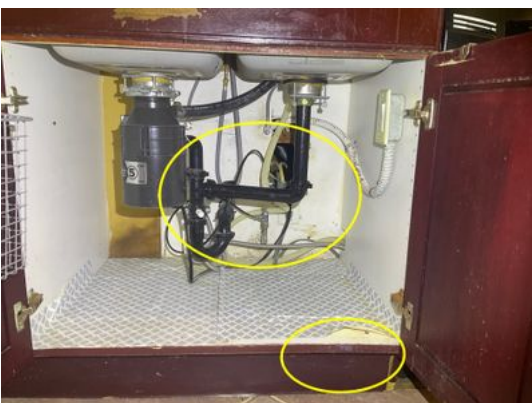
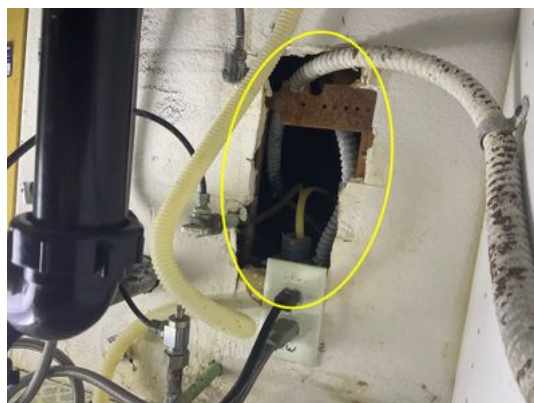
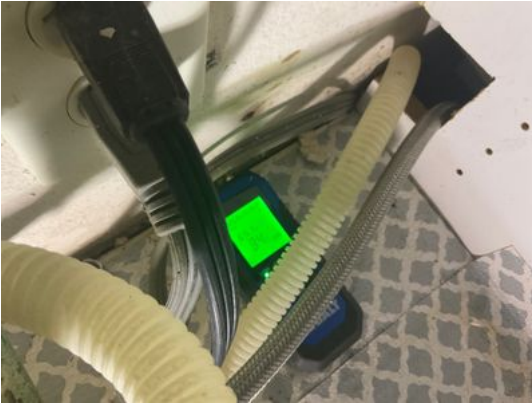
Comment 135

Water damage and visible apparent mold at wall and cabinet under sink. Drywall has been cut open. Low levels of moisture detected with moisture meter.

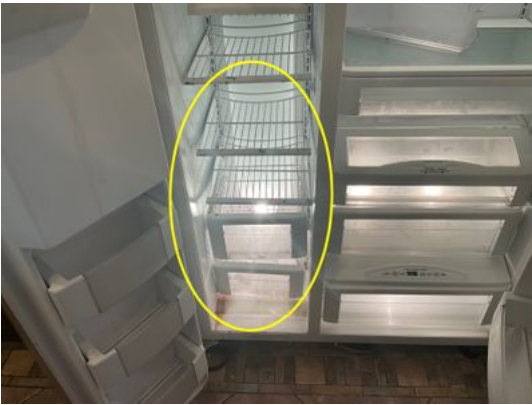
Visible apparent mold inside freezer.

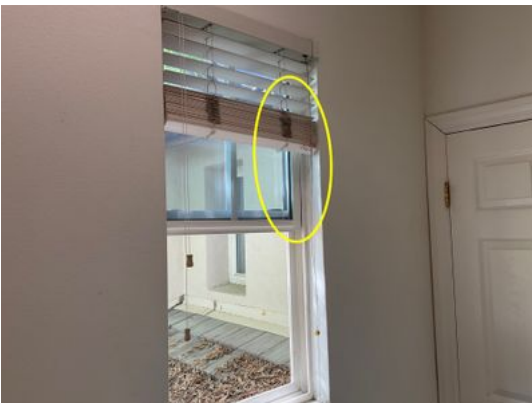
Window balance spring is damaged.

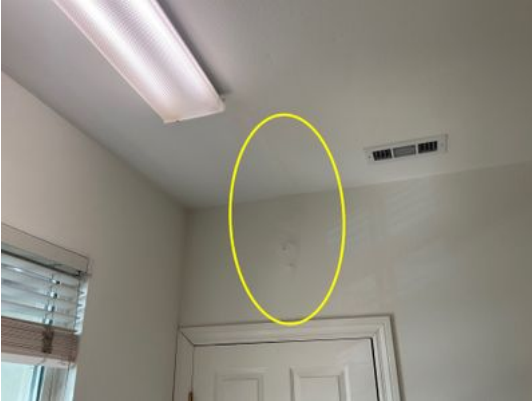
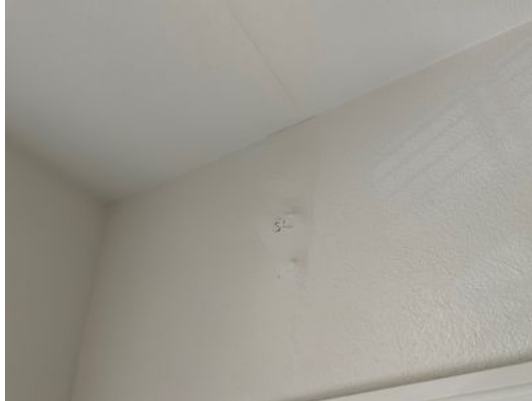
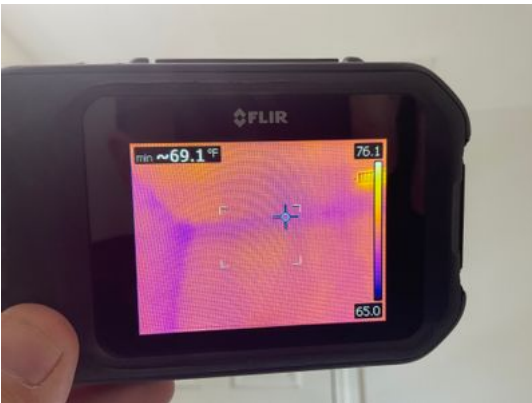
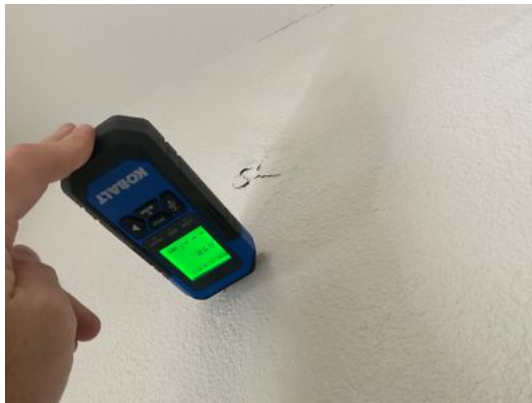
Water damage at ceiling and wall above door. Low levels of moisture detected with moisture meter.

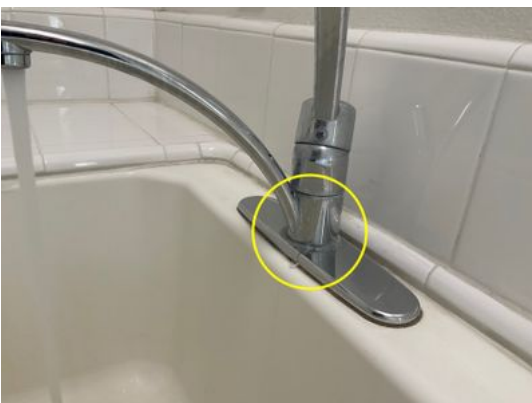
Comment 140

Defect

Sink faucet leaks.

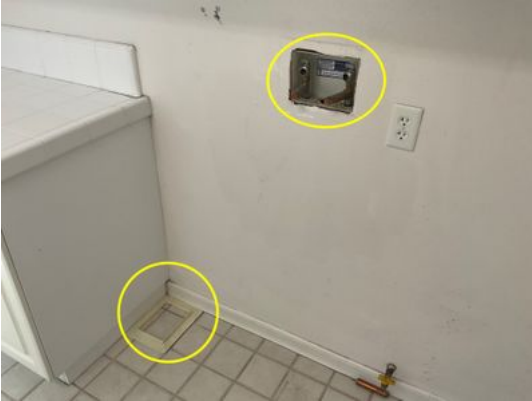
Comment 141

Defect

Trim is detached at hookups.

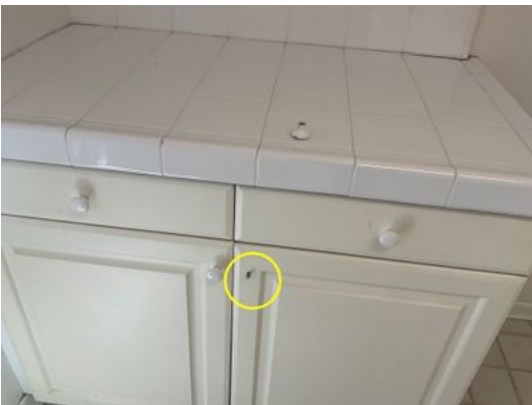
Comment 142

Defect

Knob is broken at cabinet door.

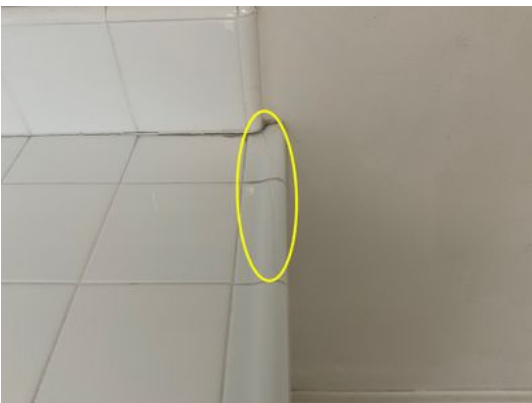
Comment 143

Defect

Countertop tile is cracked.
